Comparison of indoor climate analysis according to current climate guidelines with the conservational investigation using the example of Linderhof Palace

Kristina Holl

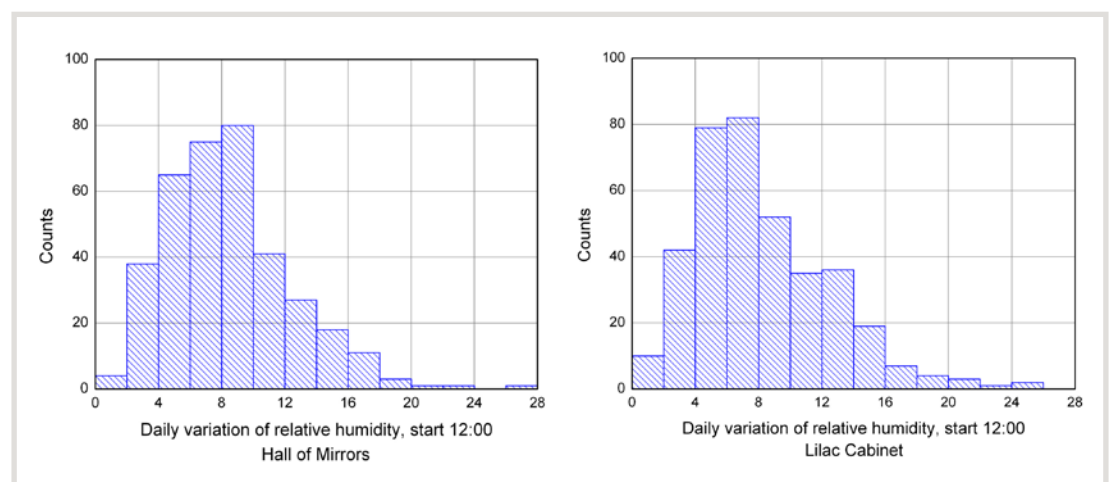
Figure 3. Histogram of the daily variation of relative humidity by the hourly mean. **Left:** Hall of Mirrors; **Right:** Lilac Cabinet. Both rooms show similar daily fluctuations of RH

The indoor climates of each room in the palace differ substantially. Two rooms located at opposite ends of the palace were chosen to illustrate the differences. The Hall of Mirrors is south facing, and the Lilac Cabinet is at the northwest of the palace. Climate data were captured from loggers located in the middle of each room. The graph (Figure 4) shows data from 11 January 2011 to 10 January 2012. The differences in temperature, relative and absolute humidity between both rooms are illustrated by the grey line. In the Lilac Cabinet, the relative humidity was always higher than in the Hall of Mirrors, while the temperature was always lower. The rooms have a mean difference in relative humidity of 9.7 %, and a mean temperature difference of 2 K, but both have similar daily fluctuations as figure 3 shows.

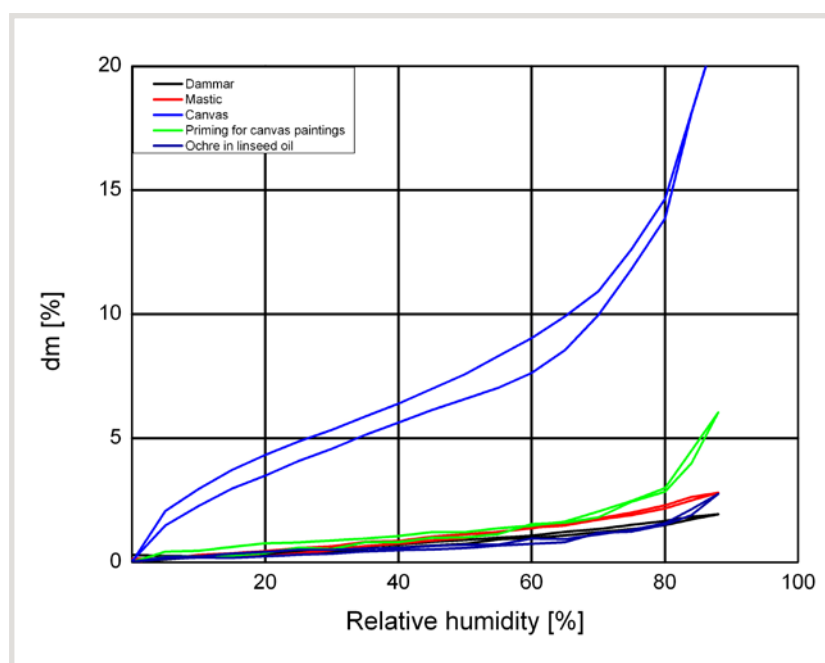
Figure 5. Diagram of sorption isotherms on organic materials: canvas, priming for canvas paintings, ochre in linseed oil, and dammar

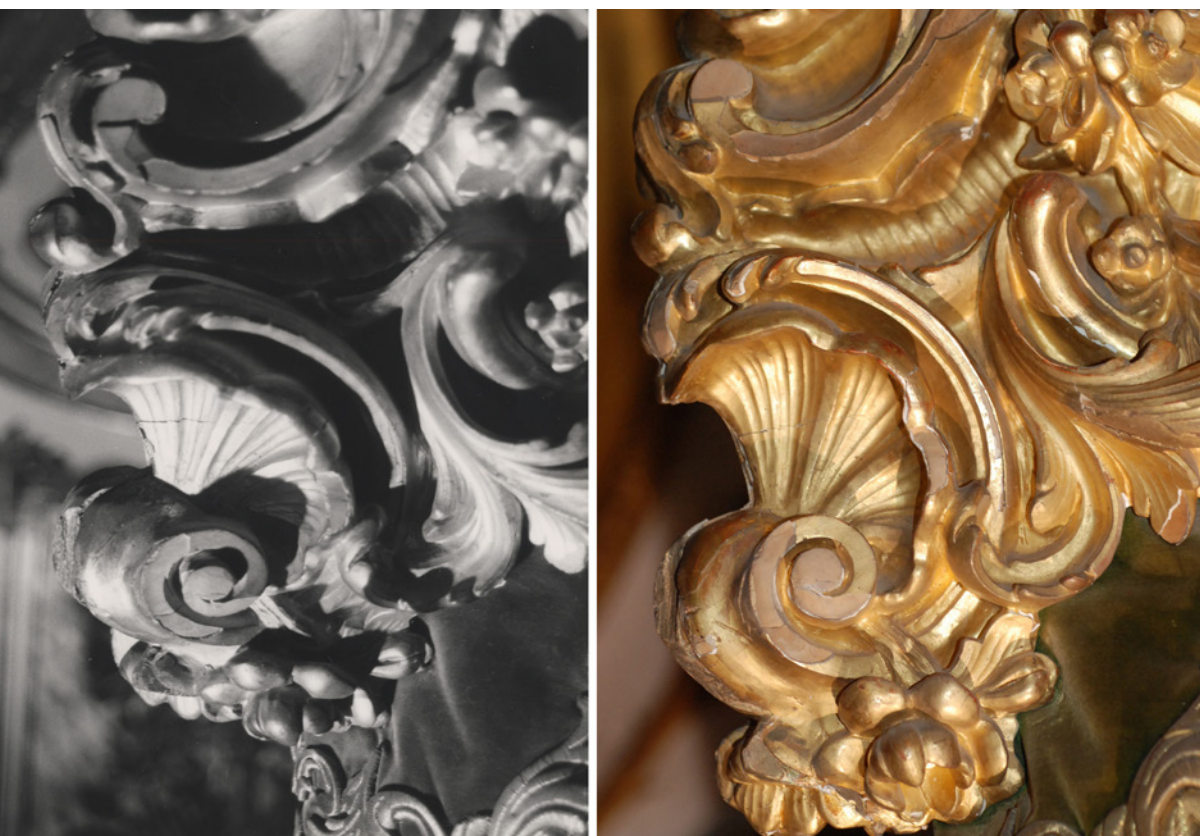
Different observations can be made about the various materials examined. Fragile objects, for example pastels and textiles, were greatly affected by the climate. Materials insensitive to environmental changes, such as porcelain vases, were in a very good state of preservation. Furnishings located in the middle of the room had not changed significantly during the last two decades. Damage like loss of gilded surfaces were already visible on the pictures from 1992 (Figure 6).

Figure 6. Audience room, east wall, gilded ornaments on the baldachin: losses and loosening of the gilded surfaces have not increased during the last 20 years

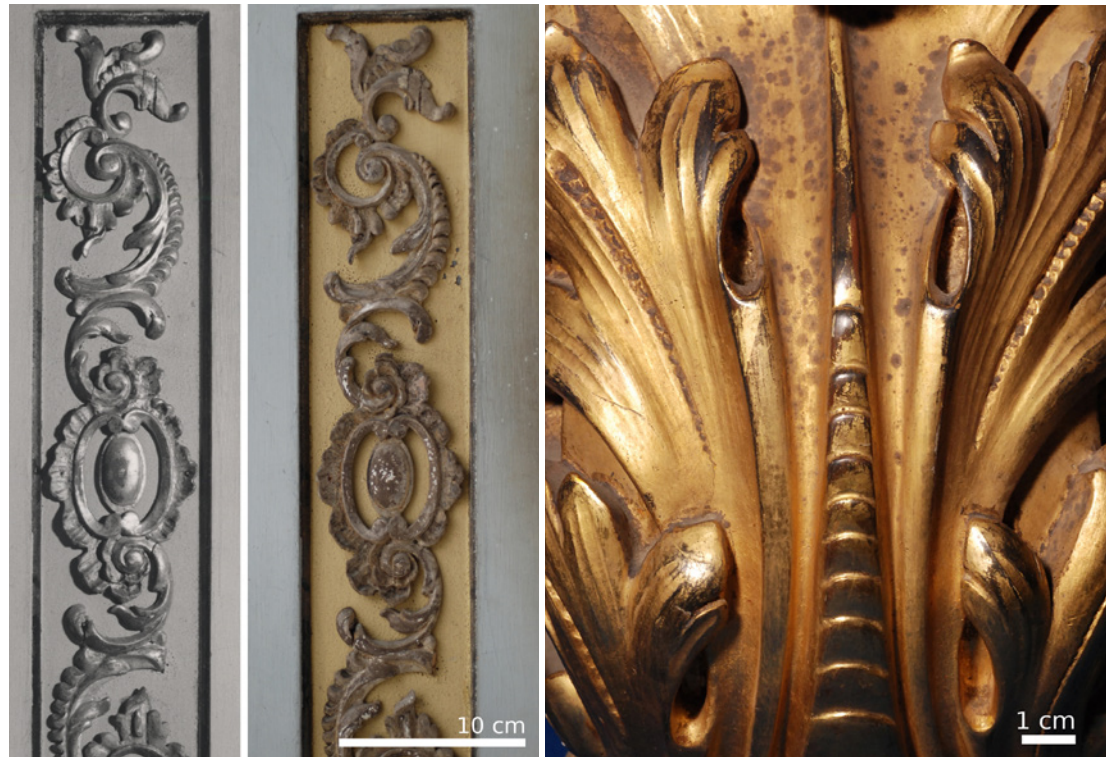
The biggest changes in condition were observed in gilded wooden decorations installed near to or on outer walls (Figure 7). Most notably the folding shutters, decorated with gilded sand-textured surfaces and wood carved ornaments, presented heavy losses and loosening. Paintings on canvas hanging on outer walls, as in the audience chamber, were heavily warped as a result of their exposure to severe environmental fluctuations. Only few craquelures were visible.

Figure 7. Yellow Cabinet, western wall, heavy losses to the silvered ornaments

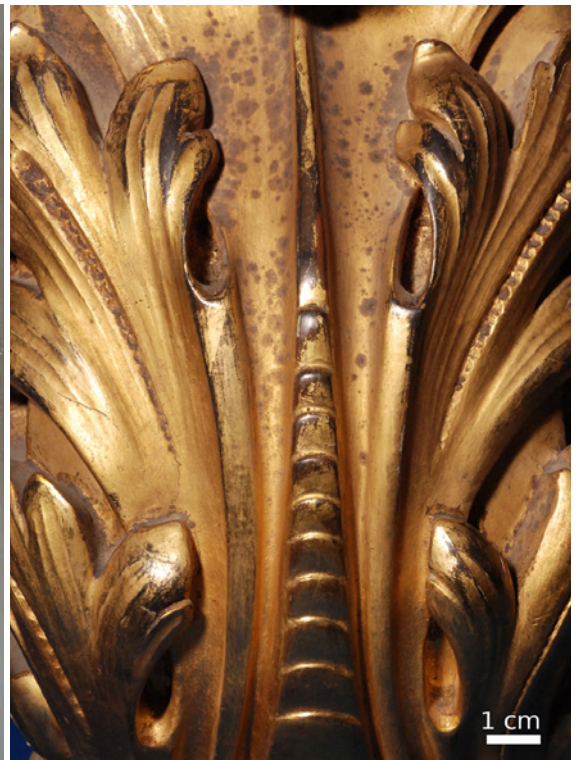
Mould growth⁵ was found in many areas, particularly in corners where the air exchange was very low, such as in folded shutters and the state bed (Figure 8). Separated from the visitors by a balustrade, the wooden gilded bed, furnished with a coating made of glue, presents an ideal medium for fungi. In some areas the painted wooden surfaces, which have been painted over with an acrylic medium, are flaking probably due to temperatures below the glass transition temperature of the binder.

Figure 8. Mould growth on the gilded state bed in the King's bedroom
