# Aixtron user meeting at ICSCRM 2015

## Quality control of SiC materials by optical detection of defects

B. Kallinger, D. Kaminzky,  
K. Roßhirt, Patrick Berwian,  
J. Friedrich

**Fraunhofer IISB**  
Materials Department  
Schottkystrasse 10  
91058 Erlangen  
Germany

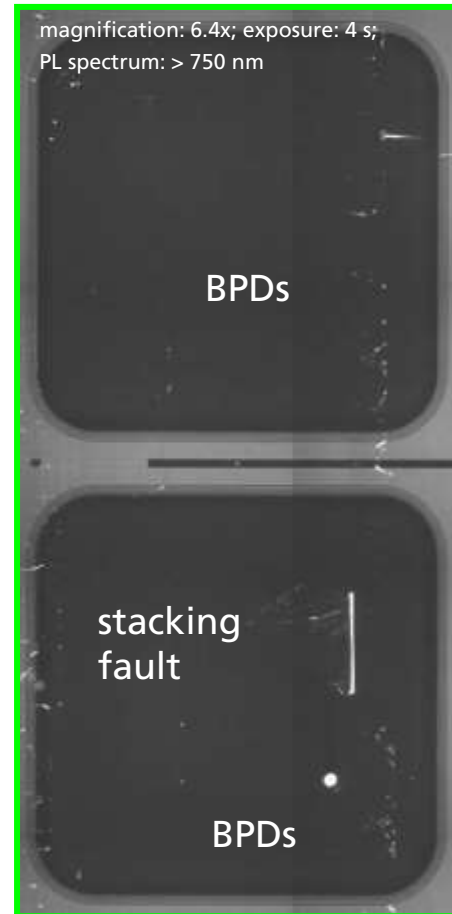
# UVPL imaging of partially processed wafers

6.5 kV PiN diodes fabricated within „SiC-WinS“ project;  
diode size 3.5 x 3.5 mm<sup>2</sup>.  
magnification: 6.4x; exposure: 4 s; PL spectrum: 400 – 1000 nm.
