NDT for Need Based Maintenance of Bridge Cables, Ropes and Pre-Stressed Elements

Within the frame of the Franco-German project FilameNDT steel wires of external tendon ducts and prestressing strands, prestressing rods, and stay cables are investigated. With regards to this field of application, practical relevance can only be gained when easily applicable and long ranging methods are used. The evaluation of extended structural elements using non-contact movable systems (bulk wave and guided wave application (Piezo, Electromagnetic Acoustic Transducers (EMAT)), Magnetic Flux Leakage (MFL), Micromagnetic methods) and those of localized elements based on elastic guided wave propagation – are complementary since they can be applied according to the various accessibility conditions of the tested objects. Inspection and monitoring scenarios were developed, hot spots were identified, and lab tests as well as field tests were carried out. A real cable stayed bridge in the Saarland region is available for monitoring within the frame of the project.

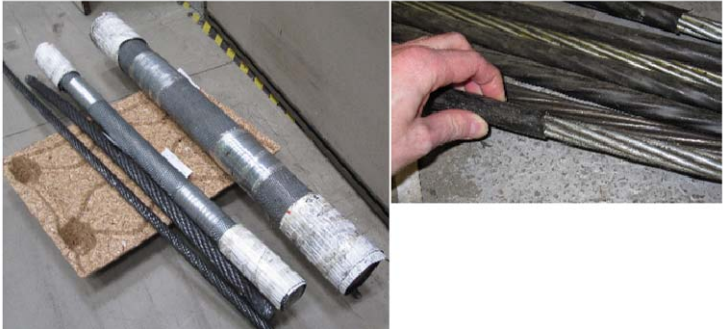
Configuration	NDT Method
<p>1. Bare cables of different diameters</p>

<p>Ultrasound guided waves (EMAT (SH – torsional mode, L – longitudinal mode)) 3MA (7 wired strand)</p>
<p>2. Fully locked rope and 7 wire strand (pure rope only)</p> <div style="display: flex; align-items: center; justify-content: center;"> <div style="text-align: center;"> <p>fully locked</p>

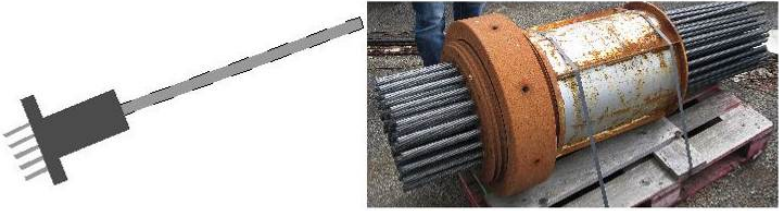
<p>3. Anchorage Zone</p>

<p>Ultrasound guided waves (EMAT (SH – torsional mode, L – longitudinal mode)) 3MA (monitoring) AE (monitoring)</p>
<p>4. Cable stayed bridge provided for inspection and monitoring (Saar river, Mettlach, Germany)</p>

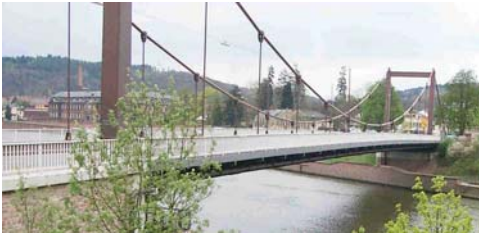
<p>Ultrasound guided waves (EMAT (SH – torsional mode, L – longitudinal mode)) AE (monitoring) 3MA (monitoring)</p>

The bridge shown in Table 1 is currently under renovation. Inspection activities within the frame of this process started in autumn 2011. This period was used for the first monitoring tests. The main renovation phase began in late autumn 2012 and during this process the concrete deck was replaced by a much lighter one. Within the frame of these activities additional load tests are envisaged for this construction. Therefore, a micromagnetic monitoring at two anchorage zones and an acoustic emission monitoring at all 4 anchorage zones was planned. The bridge has eight wire ropes on each side as elements carrying the main load. Stress changes should be equally distributed over all the wires. Therefore, not all ropes have to be instrumented. Acoustic emission monitoring for the detection of wire breaks is a well referenced approach. This method will be used for validating the micromagnetic results and to have redundant measurements for the assessment of the results. Micromagnetic measurements rely on the fact that the magnetic properties of ferromagnetic materials are strongly correlated to the mechanical properties. Using this approach, monitoring stress changes is possible. The transfer of the micromagnetic technique from the application field of material characterization and quality assurance to structural health monitoring is a new approach. However, this application needs to be tested this was performed in a first field test at the described bridge.

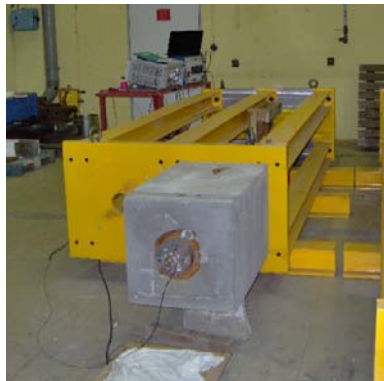
Figure 5. 5 m bench for cement grouted 7-wire strand prestressed at 80% of the ultimate strength

A bench of 5 m length including 3 prestressing 7-wire strands was used for the experiments (Fig. 5). All the 3 strands are 5m long are grouted over 2.5 m length with cement grout in a polyethylene high density (HDPE) duct. The strands are prestressed at 80% of the ultimate strength.

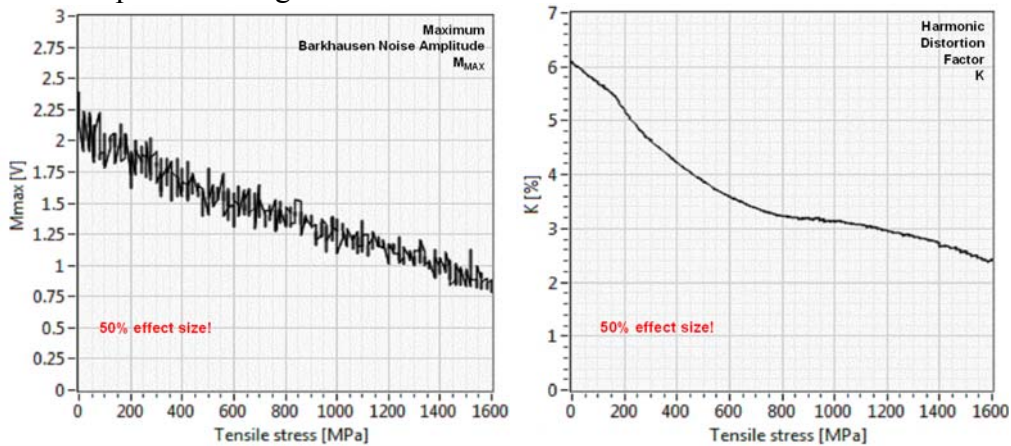
Figure 8. Results from laboratory tensile test on a strand which was provided to study the sensitivity of the approach. T15.7 strand: Young's modulus = 202 GPa, Yield strength (0.02%) = 1750 MPa, UTS = 2020 MPa

The sensitivity of the micromagnetic method was tested in the form of a laboratory tension test using a typical steel strand. The results of this test, the maximum Barkhausen noise amplitude and the harmonic distortion factor, are shown in Fig. 8. The effect size for both

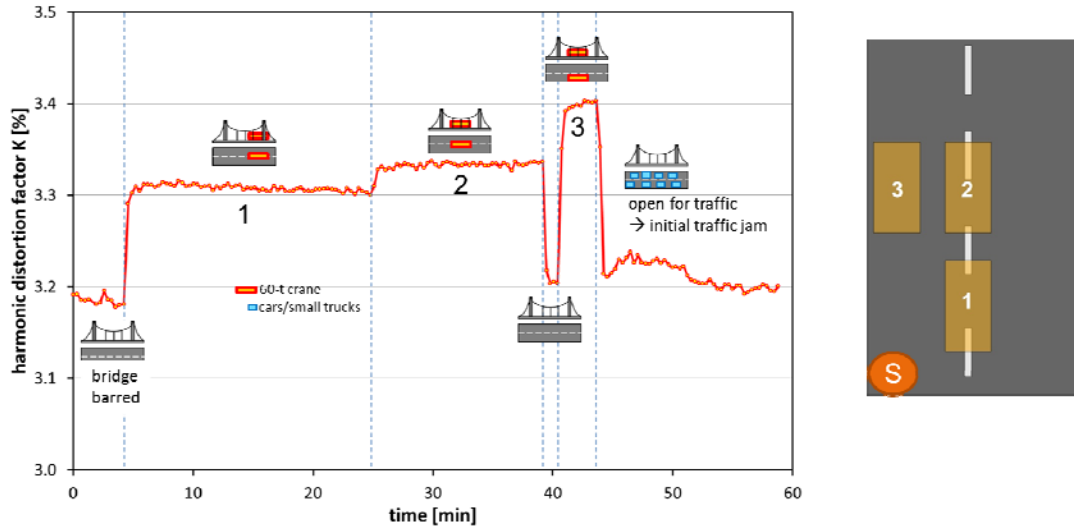
Figure 12. Result of micromagnetic stress monitoring experiment (evaluated quantity: harmonic distortion factor K) during a load test with a heavy crane. The crane positions are denoted 1,2,3, and the sensor position in relation to the crane truck is denoted “S”.

Right before the start of the renovation of the bridge an additional load test with a crane of 60 t weight was performed (Fig. 12). The crane stopped at three different positions resulting in different loading conditions. The reason for this load test was in the static assessment of the bridge before the start of the construction works. Furthermore, the load test was also used for a final calibration of the micromagnetic system which was installed first at only one anchorage zone for permanent monitoring. Three micromagnetic devices, similar to those from the first experiments as shown in Fig. 9, but smaller, with improved ruggedness and easier to apply, were attached to the cable using an elastic MS polymer glue. The reference cable was not used any further, since it was observed to react differently from the actual material at the bridge site. The three devices were applied to three of the eight bridge cables. The optimized system parameters according to the results shown in Fig. 11 were used. Fig. 12 shows the positioning of the 3 sensors at one anchorage zone and the three locations where the crane stopped for the different steps of the load test.

Fig. 13 shows the harmonic distortion factor K as one of the micromagnetic values acquired with the systems. Here, the signal of one sensors is shown revealing the different phases of the load test. When the bridge was buried for the load test at first no additional load due to traffic was on the bridge. This period represents the zero level of the signal. Then the crane moved on the bridge and stopped in the first position for about 15 minutes. This belongs to the first step-like increase of the signal. After that the crane moved on a bit towards the middle of the bridge. As expected this leads to a small increase of the signal since the increased bending in the middle of the bridge leads to a higher load at the anchorage zone. Entering the last position consisted of different steps which are all visible in the signal. At first the crane left the bridge. The signal returns to the initial level. The crane did a u-turn outside the bridge to stop again in the middle of the bridge, but now just on the lane which is closer to the anchorage zone where the sensors are situated. In the first two positions the crane stayed in the center area of the two driving lanes. As expected the signal in position 3 increases again compared to position 2 since the load was applied on the side of the sensors. Finally, the crane left the bridge and it was reopened for the traffic. This led to a small traffic jam on the bridge resulting in a small buckle in the signal between 45 and 50 minutes.
