CHARACTERIZATION OF AGED ELECTRODES OF LITHIUM-ION-BATTERY

Fraunhofer Institute for Solar Energy Systems ISE

BatteryWorld/ Battery Production and
characterization

München, 17.02.2022

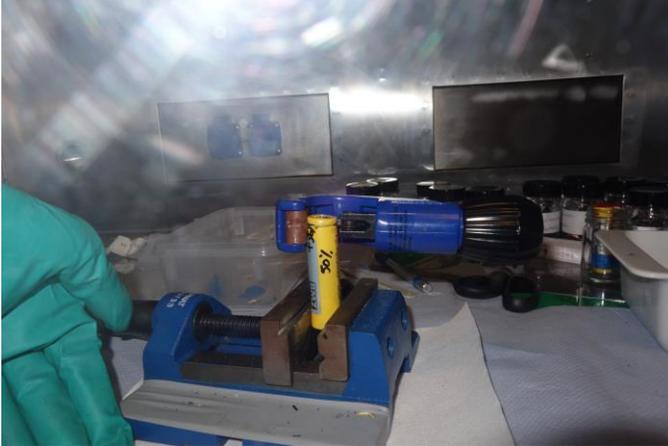
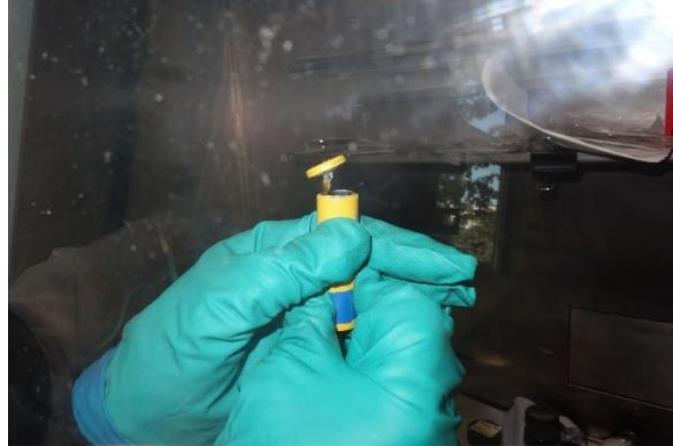
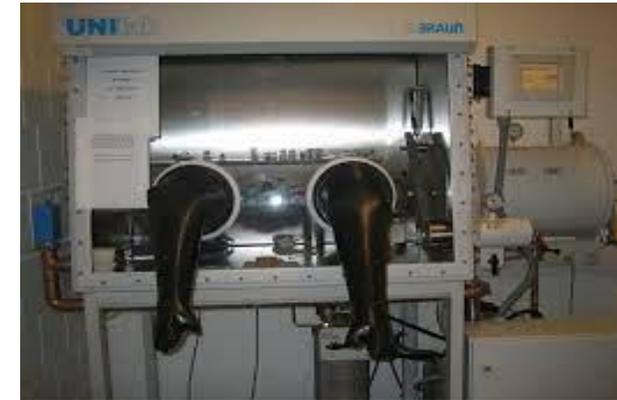
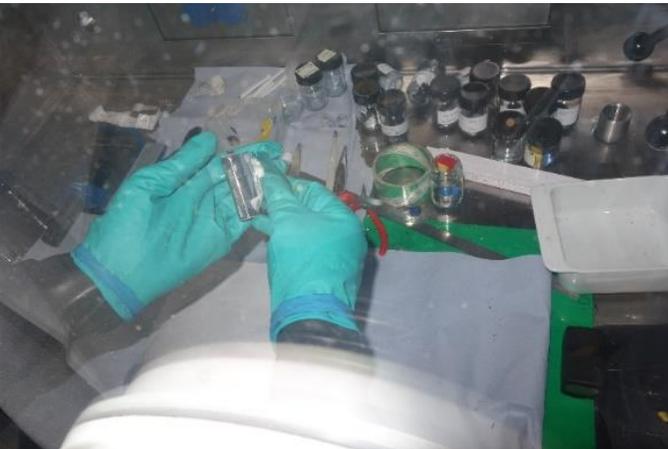
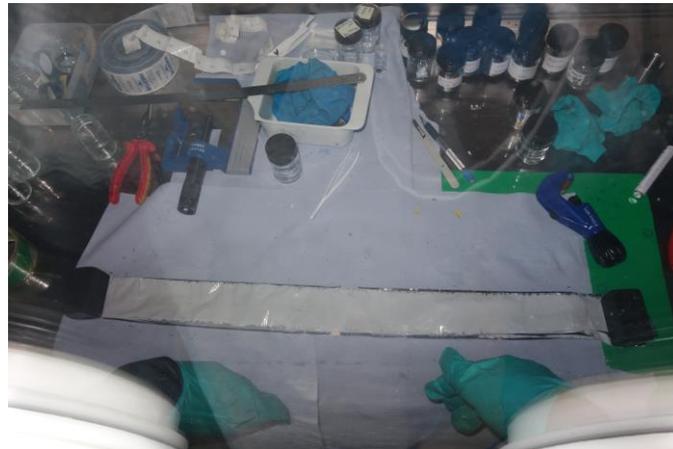
Battery cell disassembly

- Disassembly of battery cell inside the glove box

- $O_2 < 1,5 \text{ ppm}$
- $H_2O \approx 0$
- $Ar + N_2$

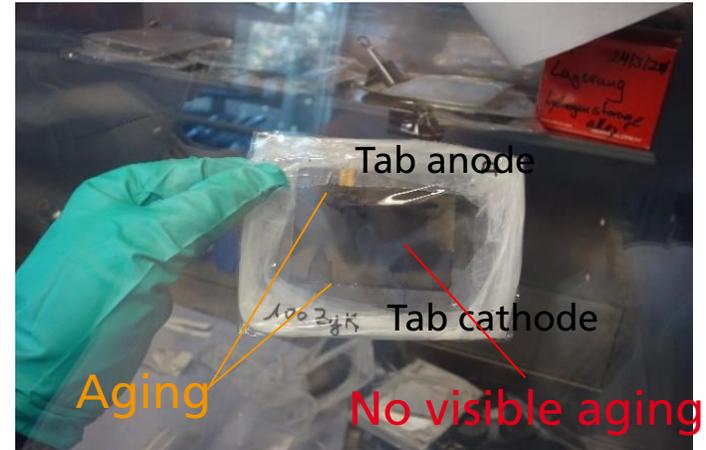
■ Covered Anode

Cover glasses (100 μ m thick) and parafilm

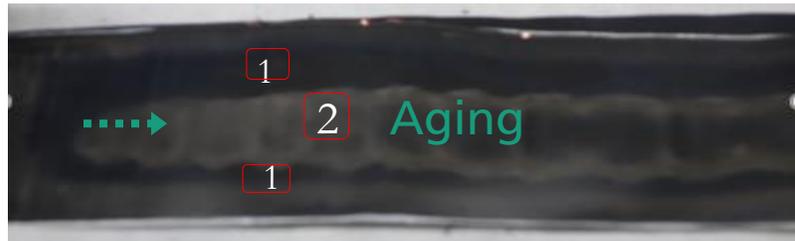
■ 100 cycles

Graphite Anode – Center of battery cell

- Visible aging at the middle of the electrode
- Graphite delamination

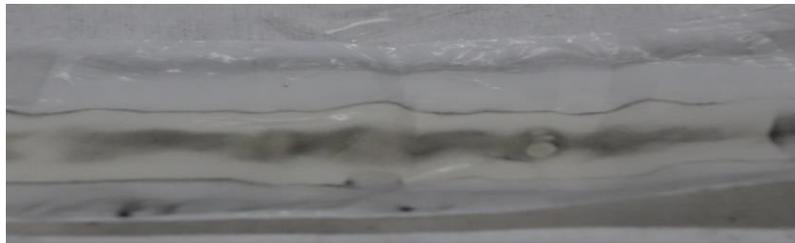
Separator - Anode interface – Center of battery cell

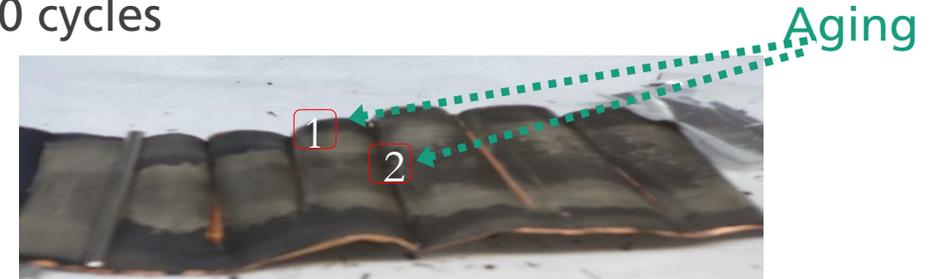
■ 250 cycles

Graphite Anode - Center of battery cell

Separator - Anode face - Center of battery cell

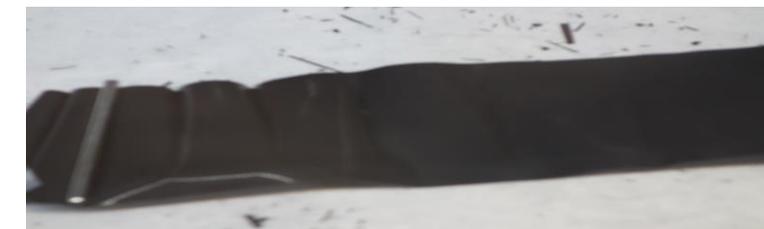
LiFePO₄ /C cathode - Center of battery cell

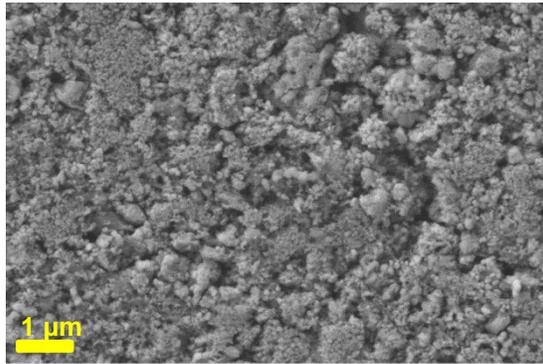
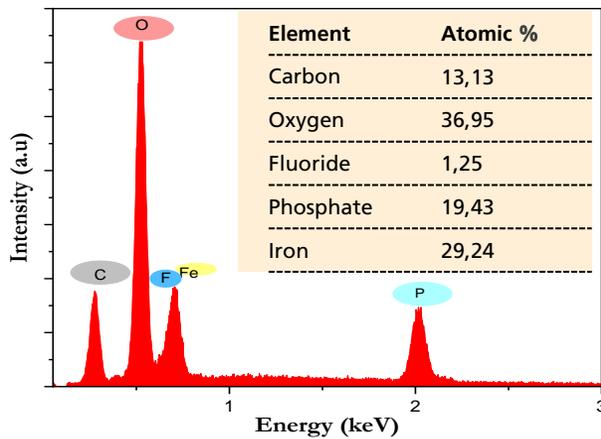
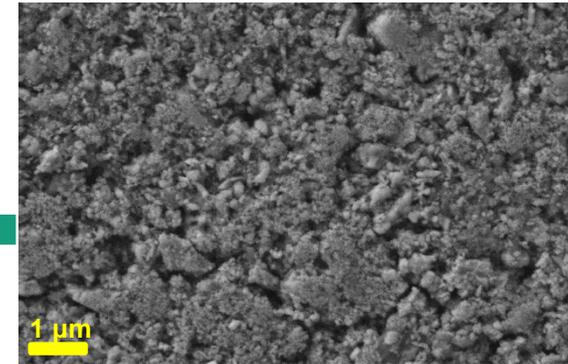
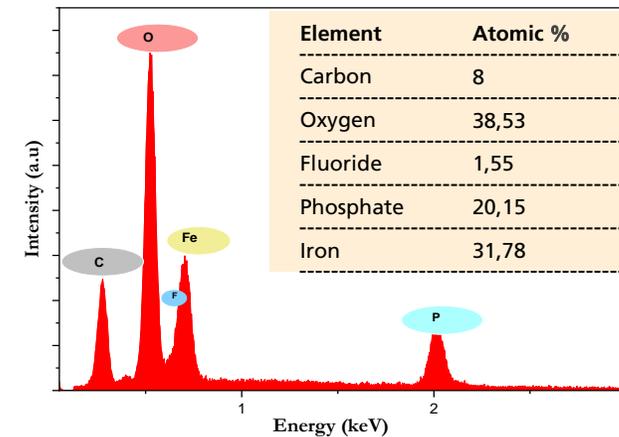
SEM and EDX images of LiFePO_4/C cathode

Neither chemical modification nor aging is observed in LiFePO_4 cathode

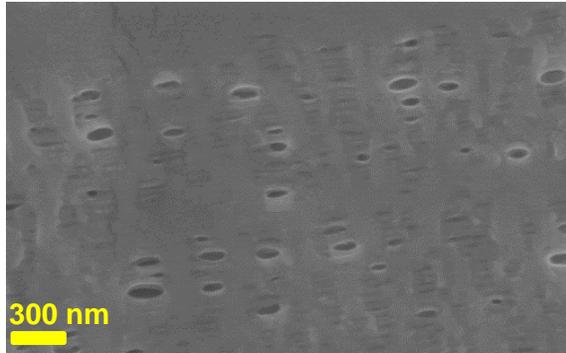
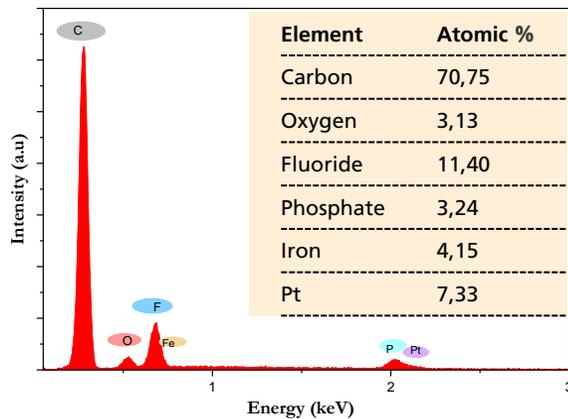
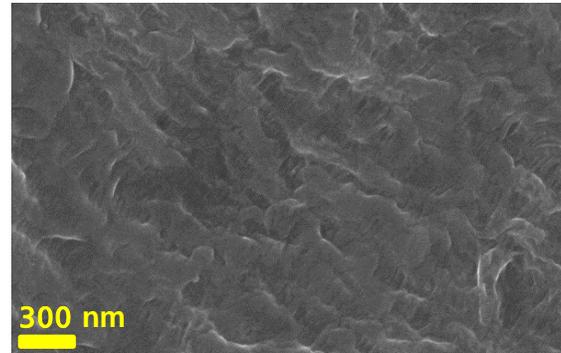
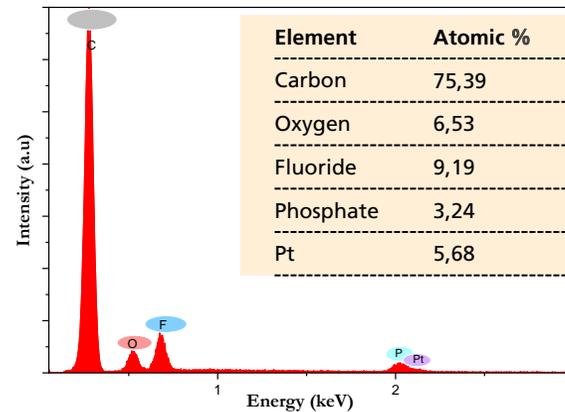
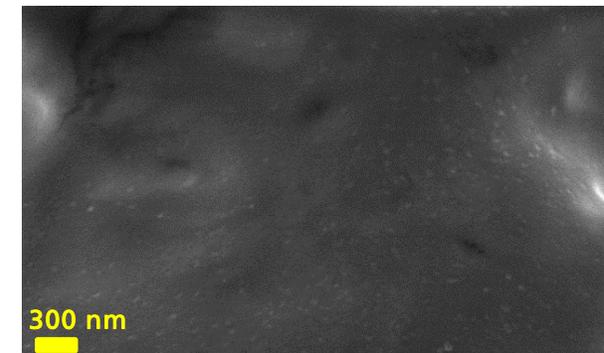
SEM and EDX images of separator - anode interface

➔ Graphite deposition on the separator – anode interface

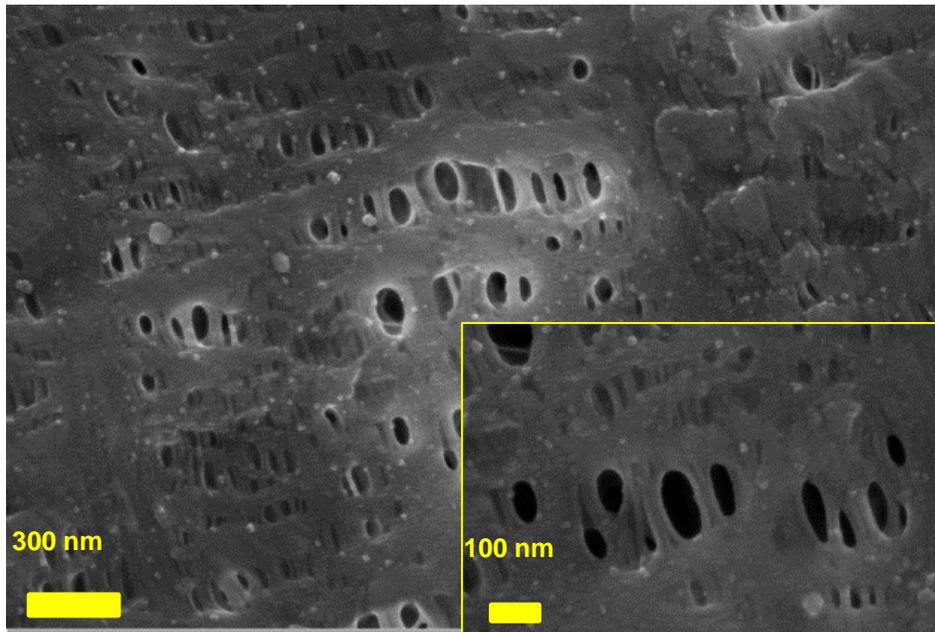
SEM and EDX images of separator - cathode interface

➔ Clean surface of the separator

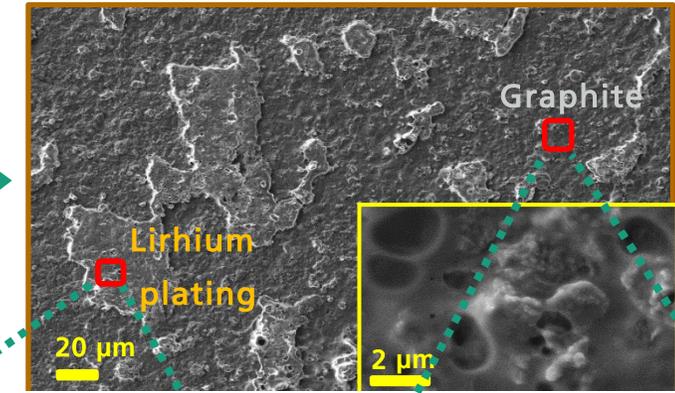
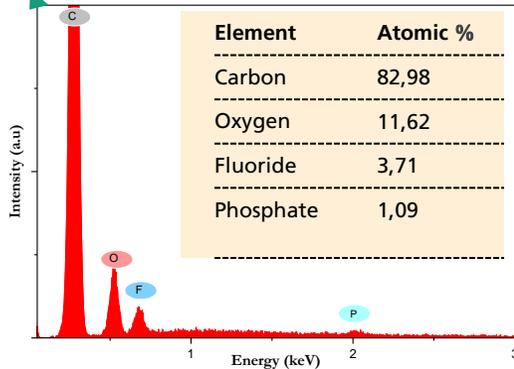
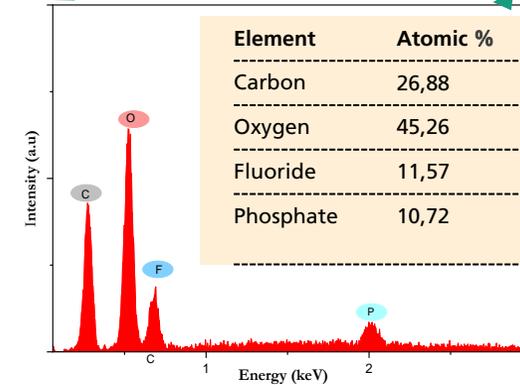
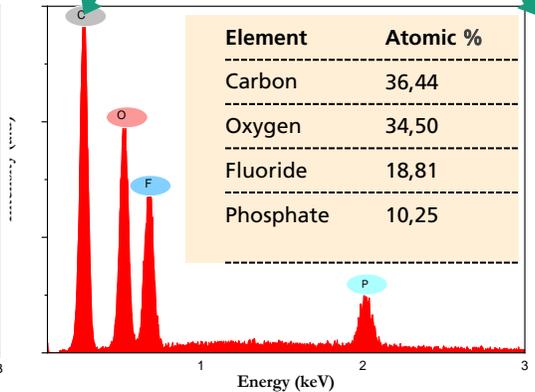
■ 100 Cycles - position 2

- Cracks
- Lithium plating

Lithium reacts with air and causes a higher concentration of O₂ compared to C.

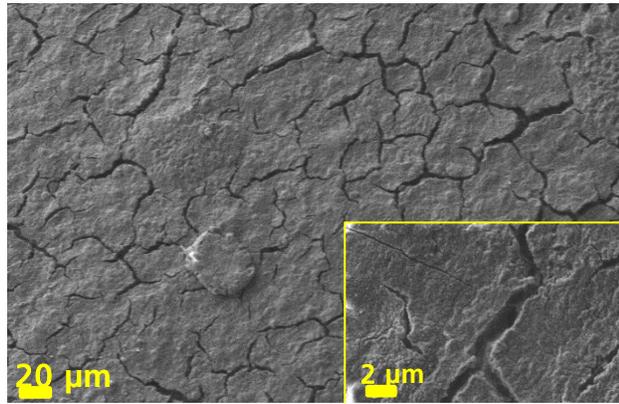
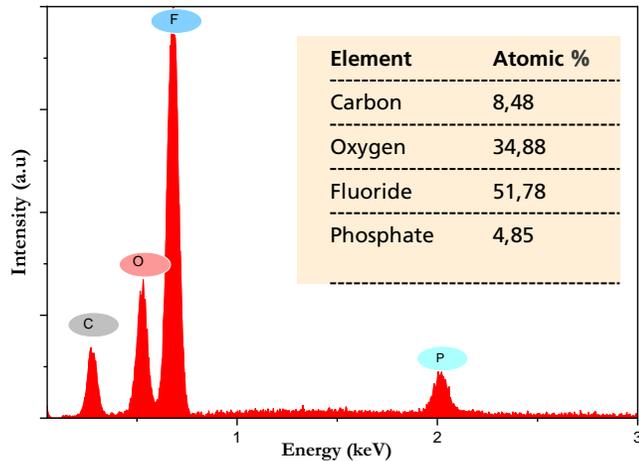
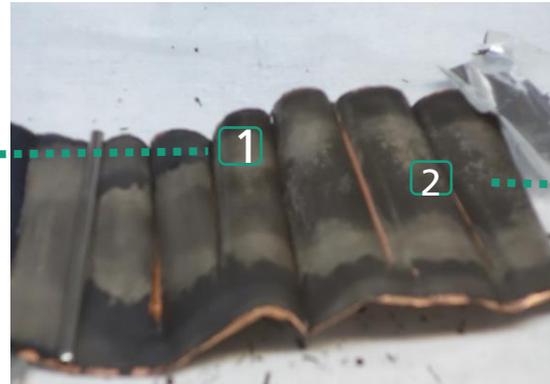
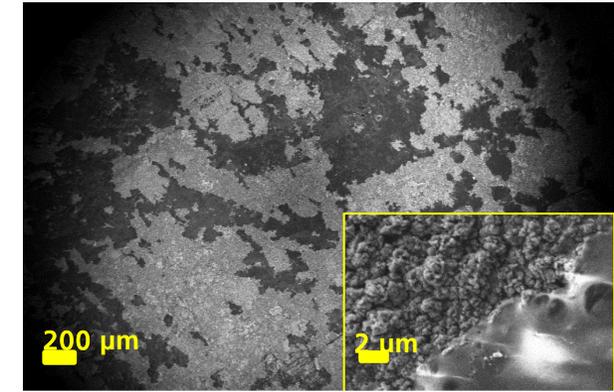
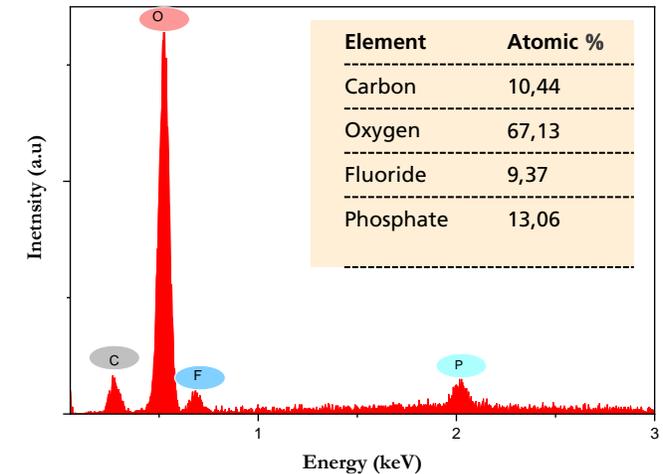
SEM and EDX images of aged graphite anode

- More cracks
- Lithium Plating

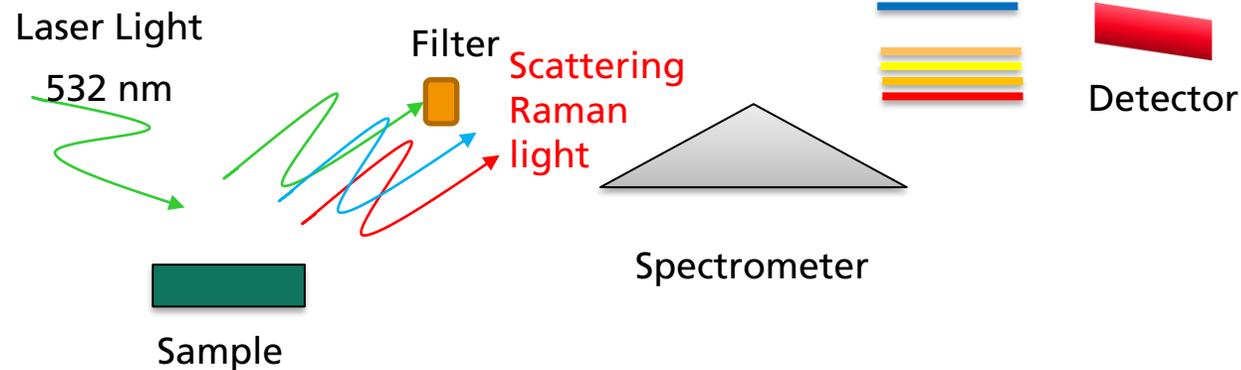
Raman mapping

- Laser wavelength: 532 nm
- Time: 1 s
- Geometry: 40 μm x 40 μm
- Number of points: 40 x 40
- Laser power: 1,4 mW

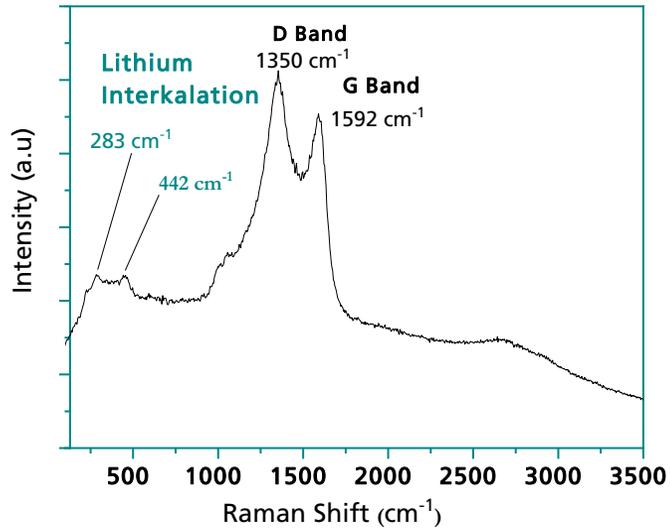
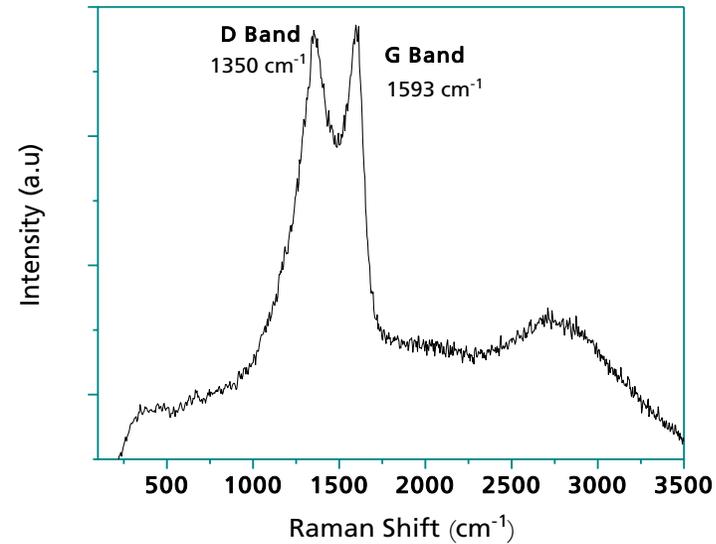
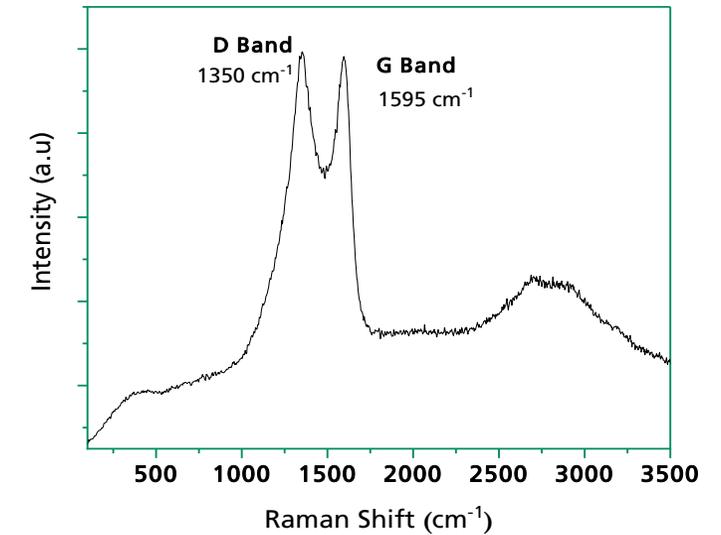
Raman results of LiFePO_4/C cathode

Difficulty to detect LiFePO_4

Carbon layer on the surface of the cathode

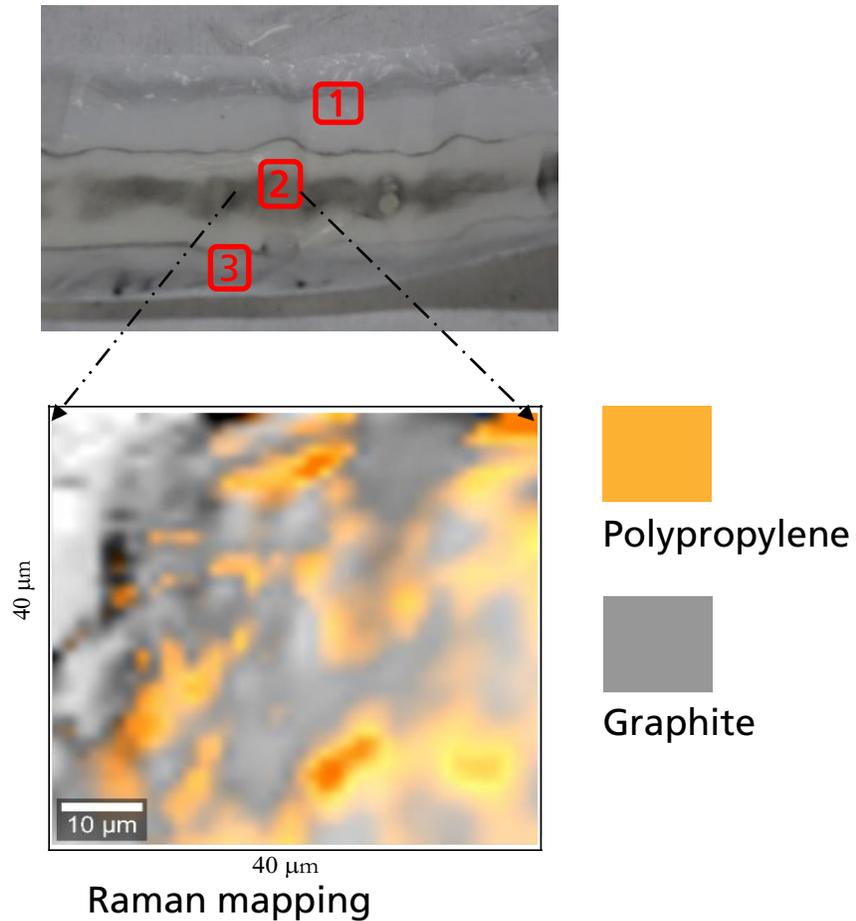
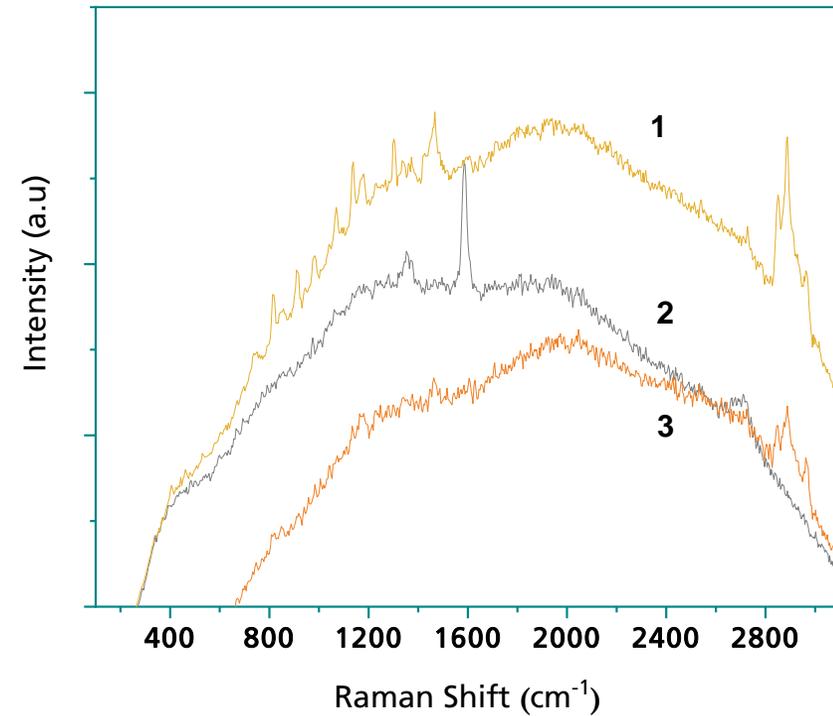
Raman results of PP separator - anode interface

➔ Graphite layer covers the surface of the separator

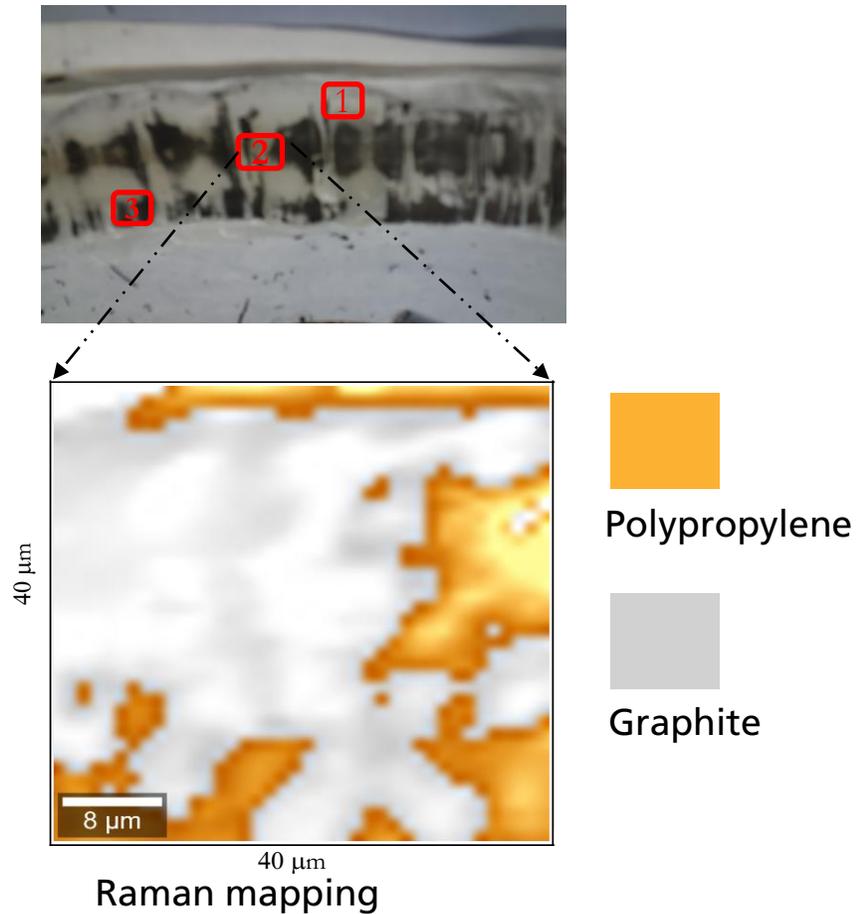
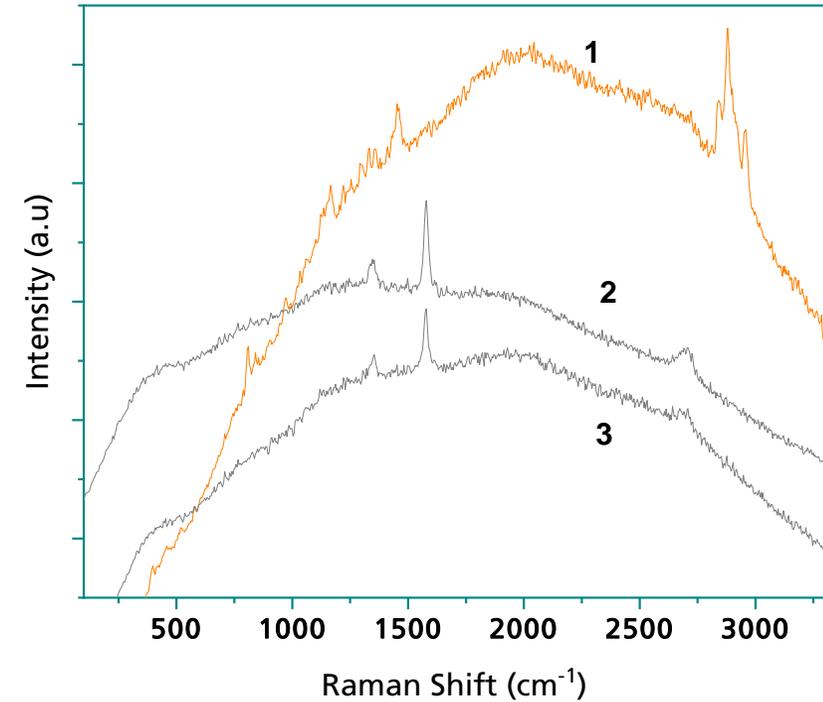
Raman results of aged PP separator - anode interface

➔ Graphite layer covers a larger area of the separator

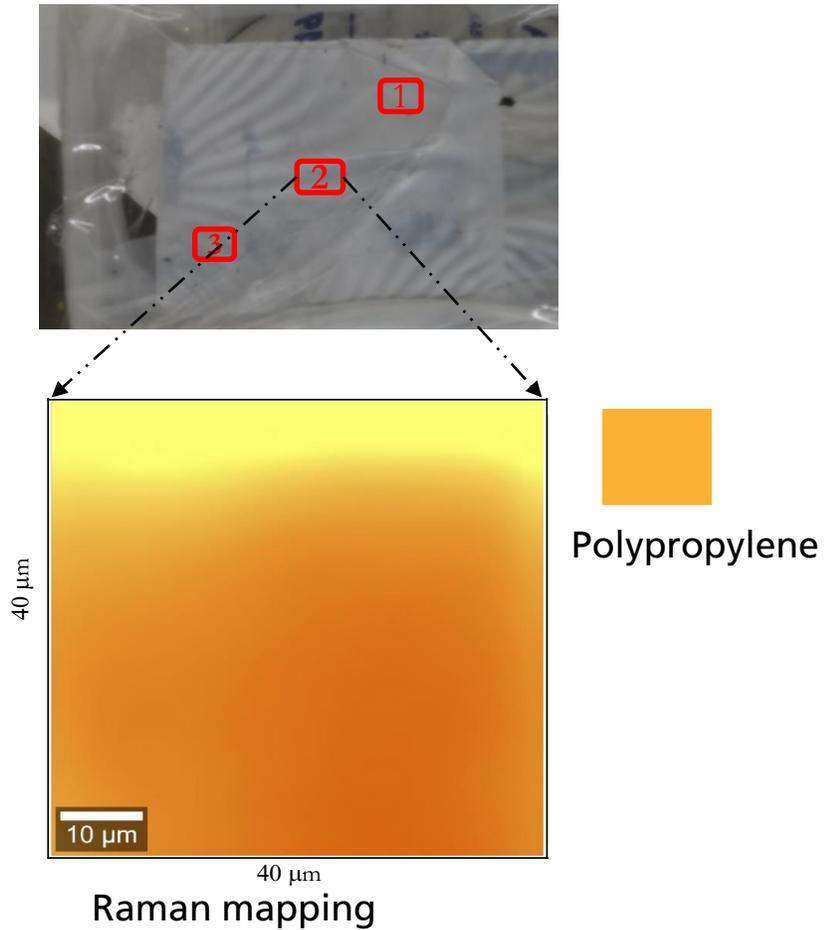
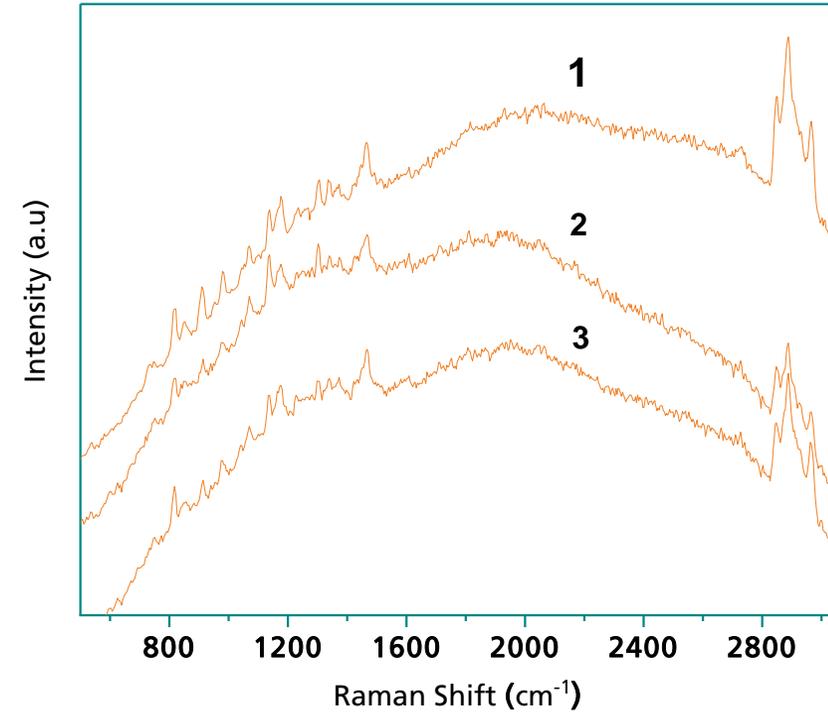
Raman results of PP separator - cathode interface

➔ Clean separator

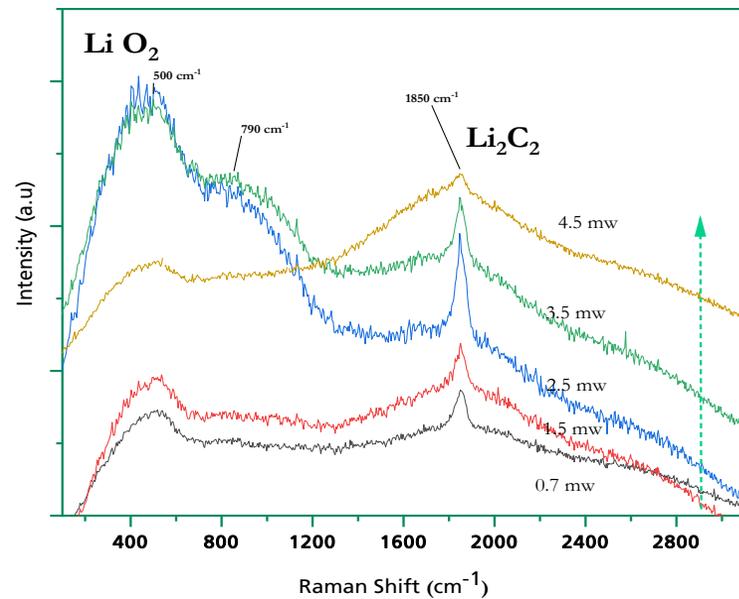
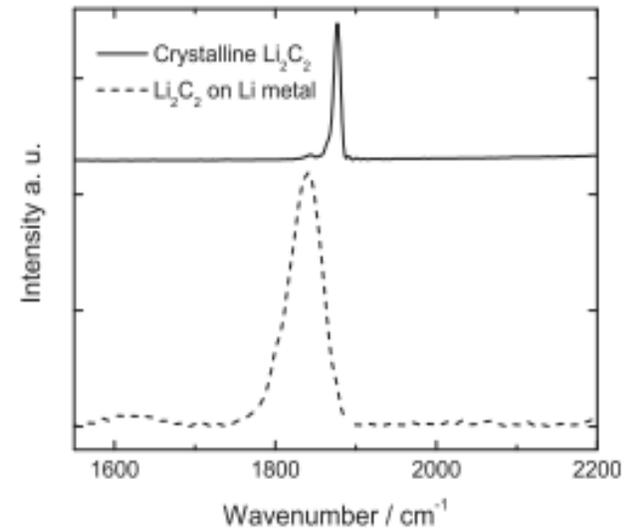
Raman results of Lithium metal

Fig. 1. Raman spectrum of synthesized Li_2C_2 (top) and purchased lithium metal (bottom) in the region of the symmetric stretching vibration of the C_2^{2-} anion.

➔ Lithium carbide Li_2C_2 band at 1845 cm^{-1}

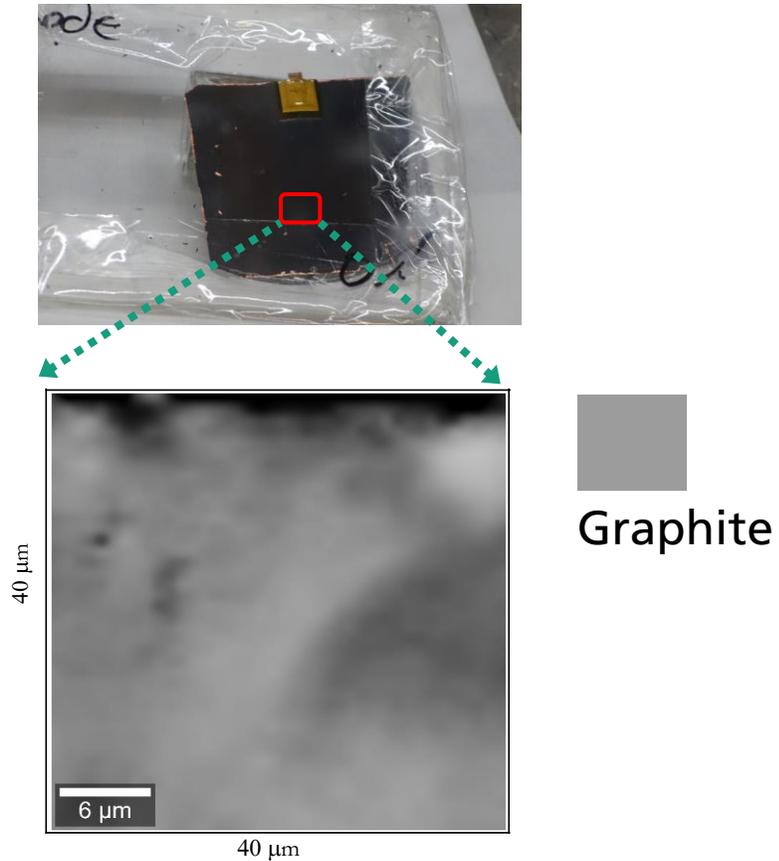
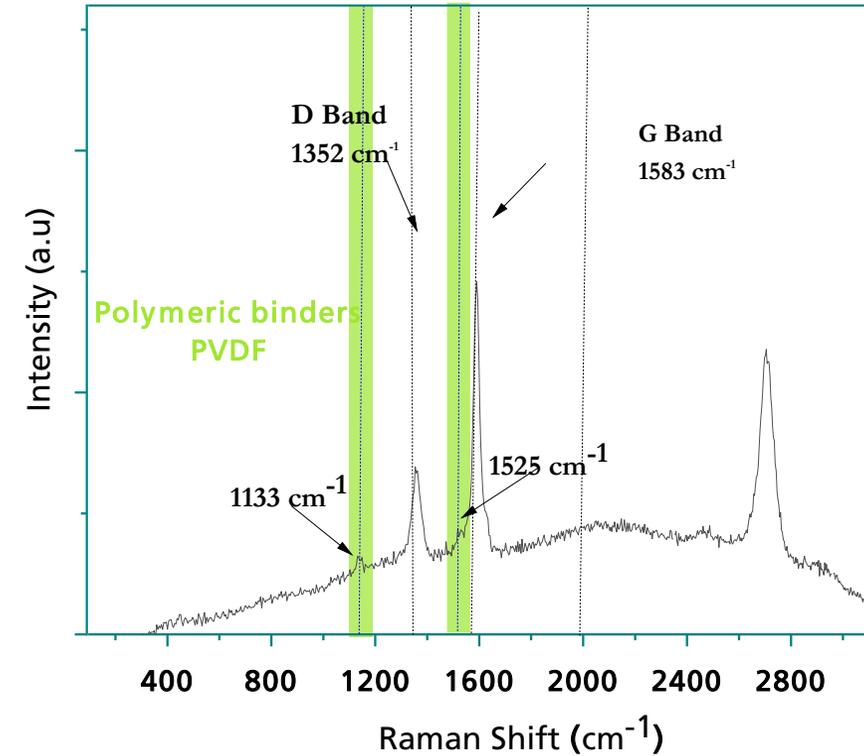
Raman results of fresh graphite anode

➔ No lithium plating

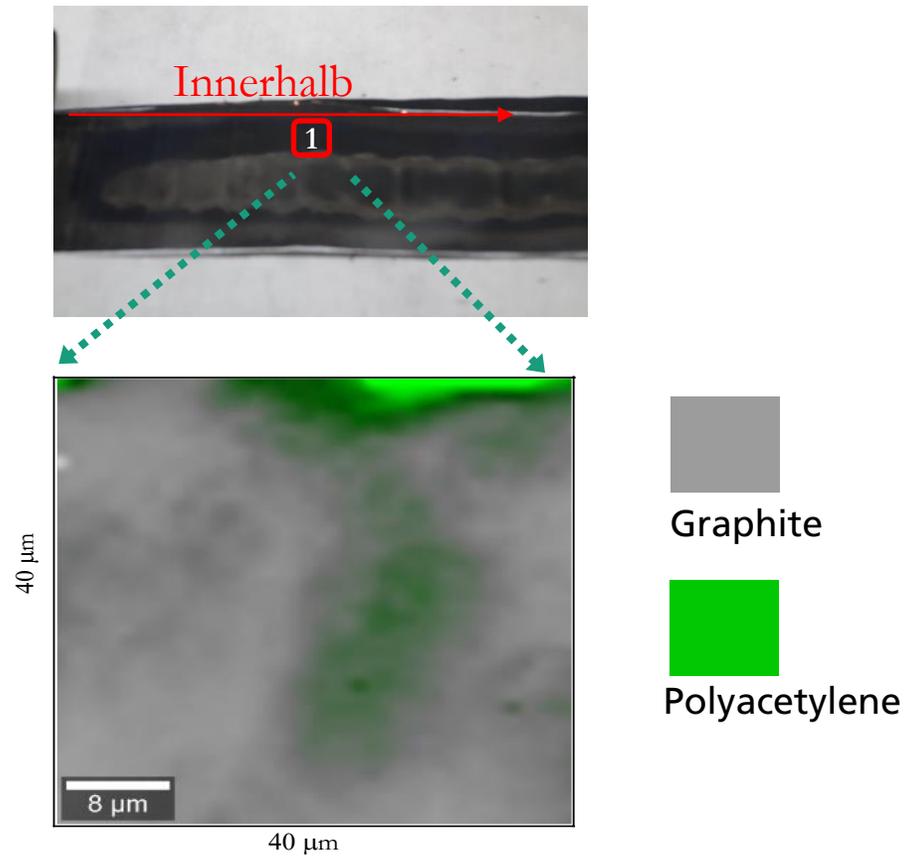
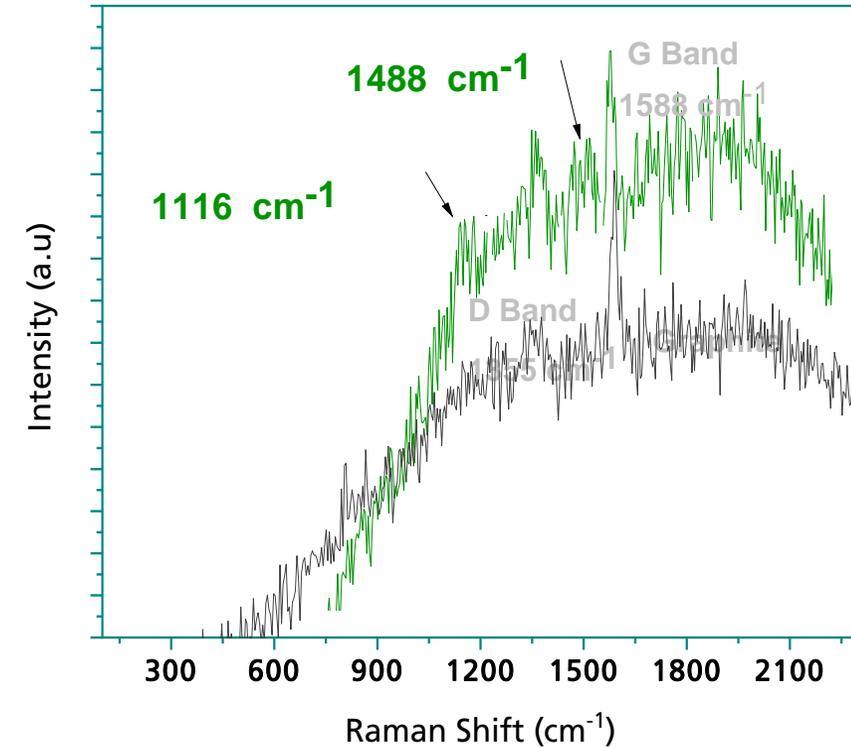
Raman results of aged graphite anode - 100 cycles

- Raman mapping of graphite anode in the edge position

➔ Start of aging: presence of polyacetylene

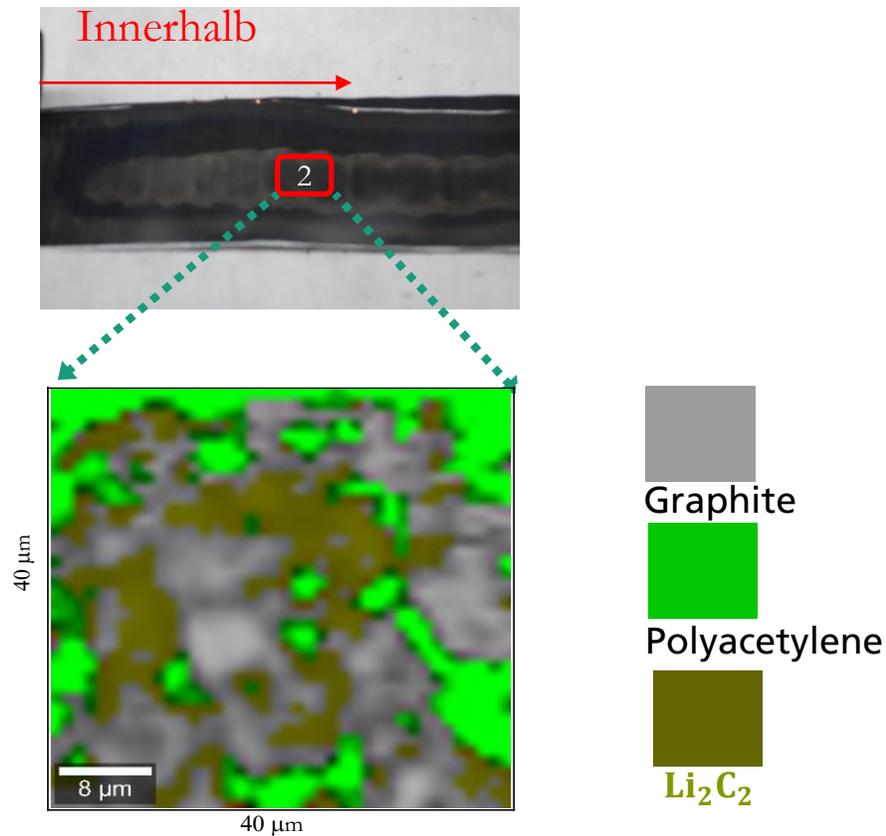
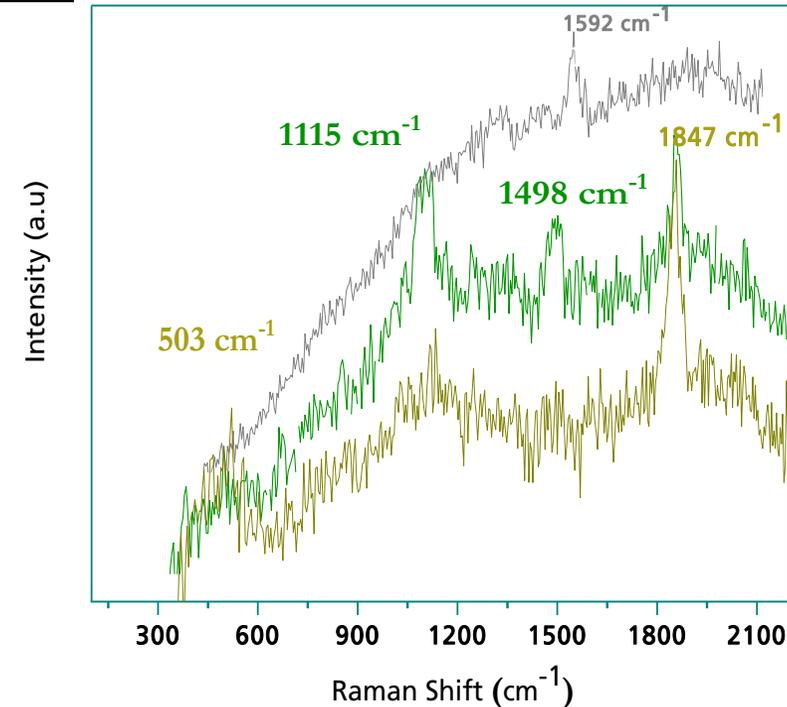
Raman results of aged graphite anode – 100 cycles

- Raman mapping of graphite anode at the mitte position

Most aging in the middle position

Stronger presence of polyacetylene

Presence of Li_2C_2

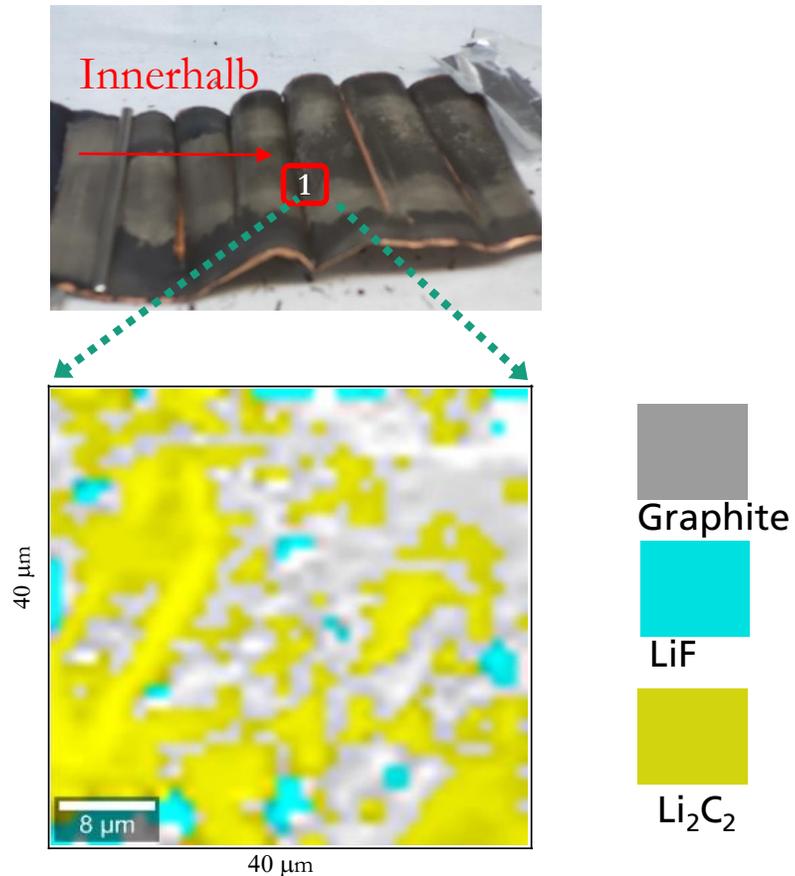
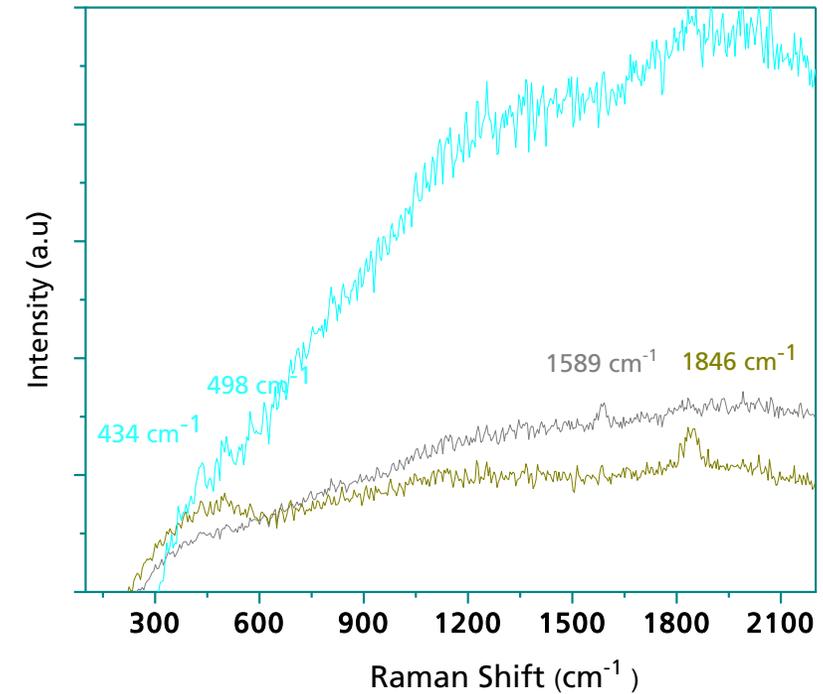
Raman results of aged graphite anode – 250 cycles

- Raman mapping of graphite anode at the edge position

➔ Appearance of lithium carbide at 1846 cm^{-1}

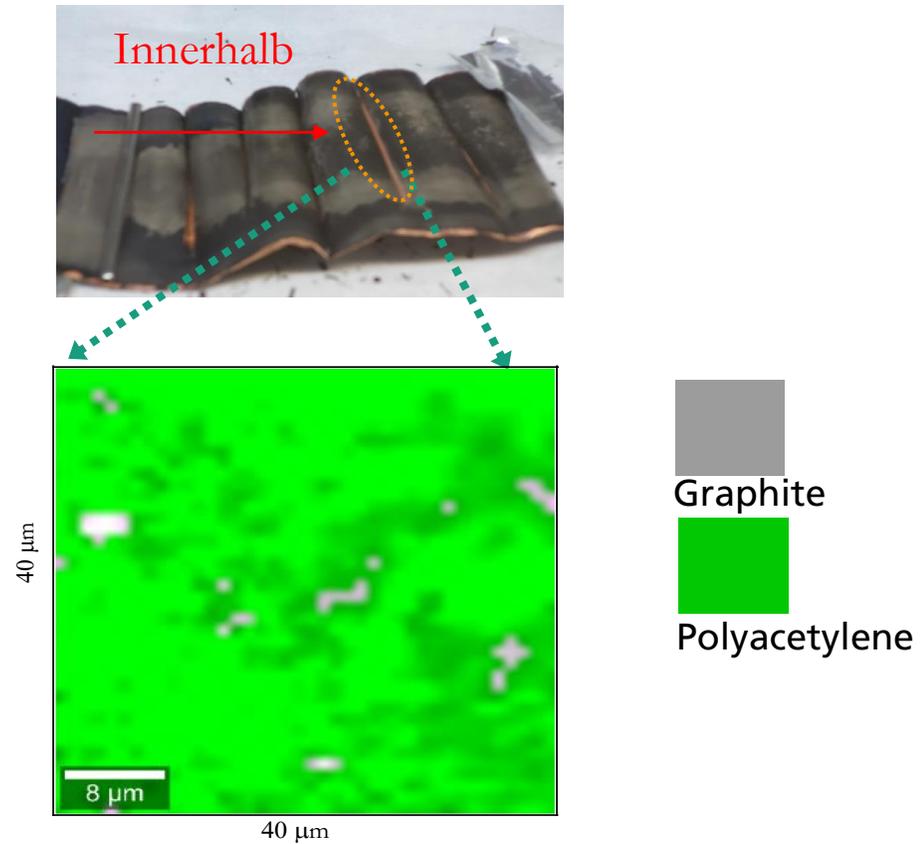
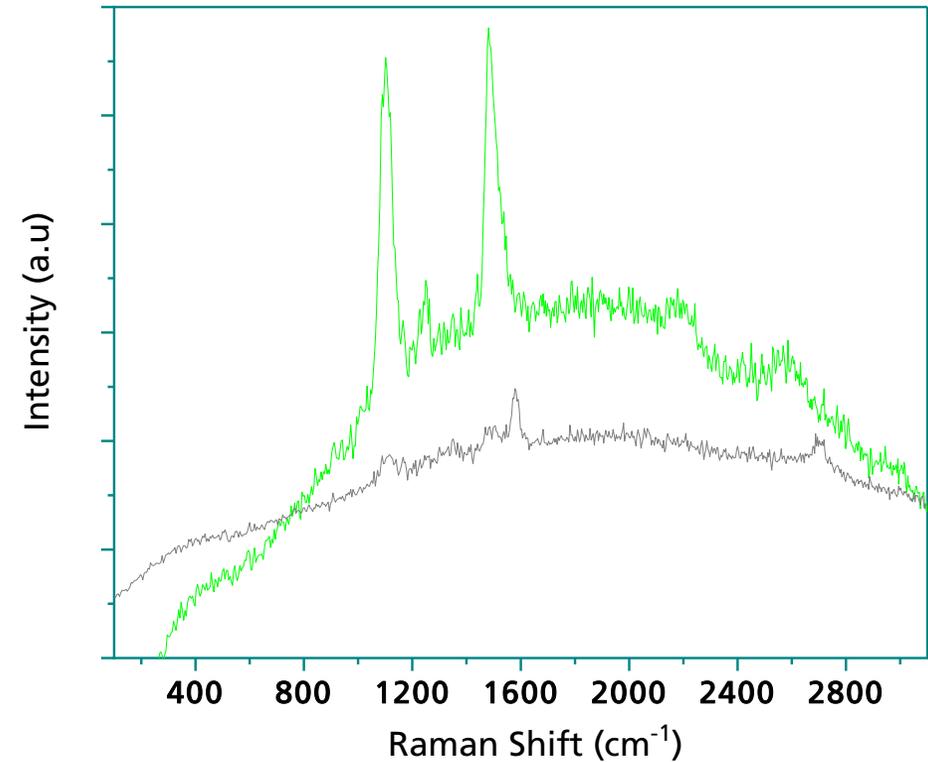
Raman results of aged graphite anode – 250 cycles

■ Raman mapping of copper foil

➔ Appearance of polyacetylene layer on the copper

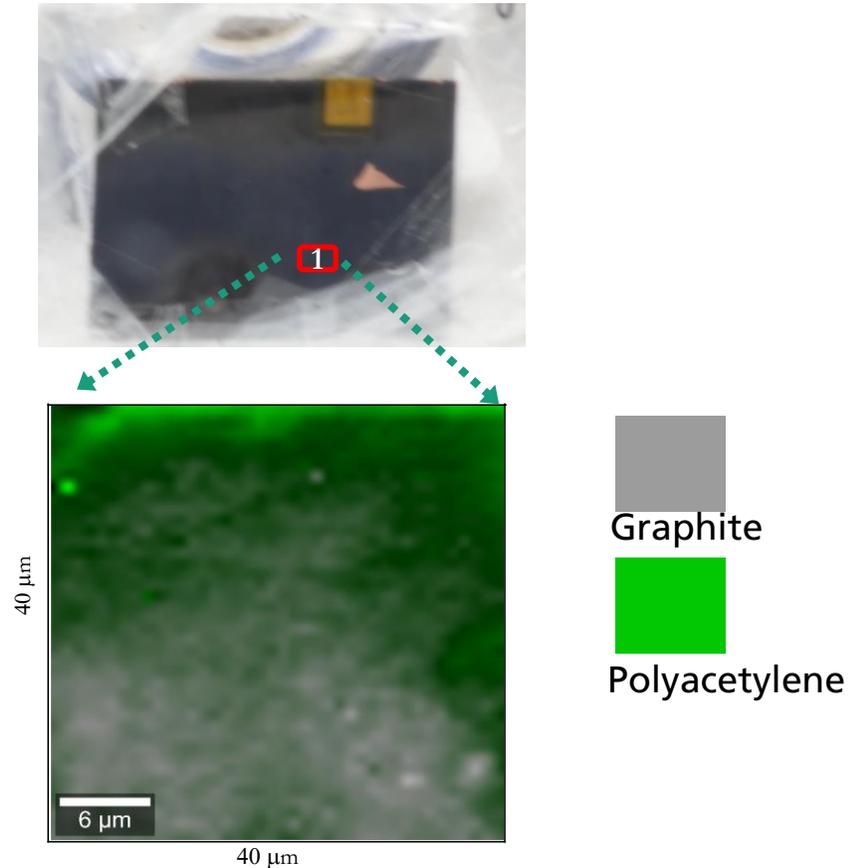
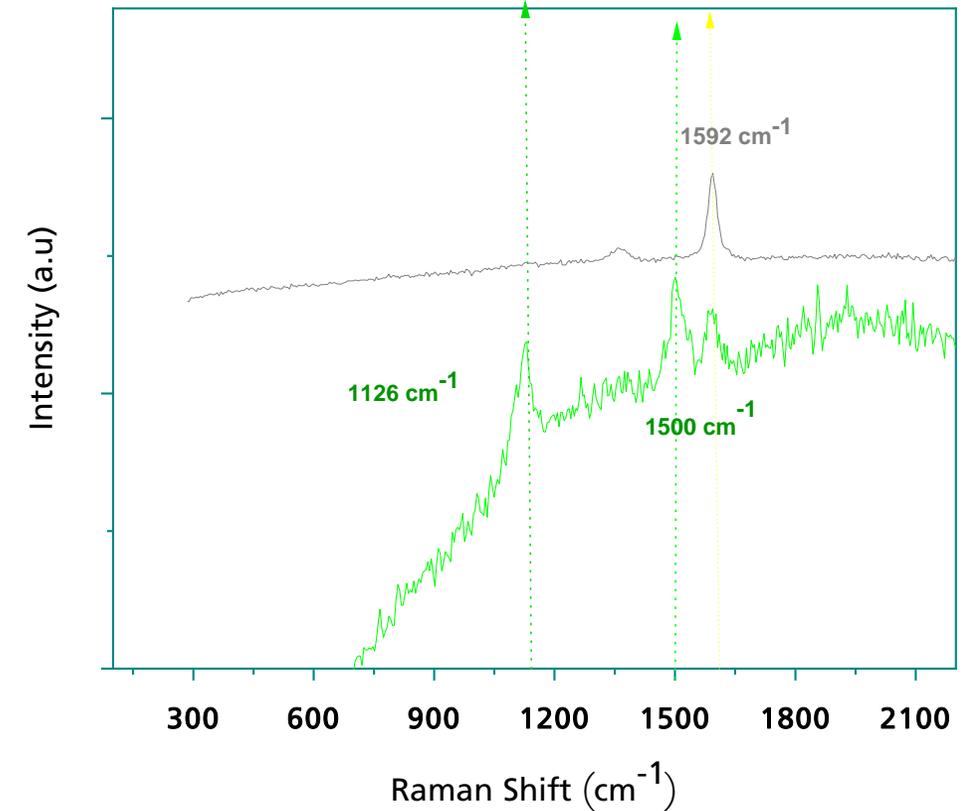
Raman results of aged graphite anode next to the cathode tab – 250 cycles

- Raman mapping image at the edge position

➔ Starting of aging with the appearance of polyacetylene
