CHARACTERIZATION OF AGED ELECTRODES OF LITHIUM-ION-BATTERY

Fraunhofer Institute for Solar Energy Systems ISE

BatteryWorld/ Battery Production and
characterization

München, 17.02.2022

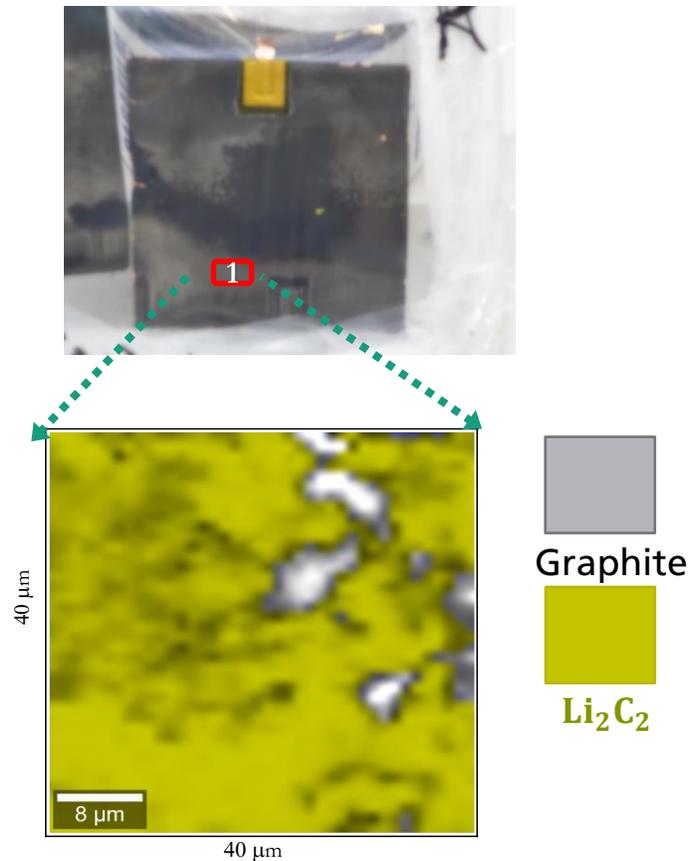
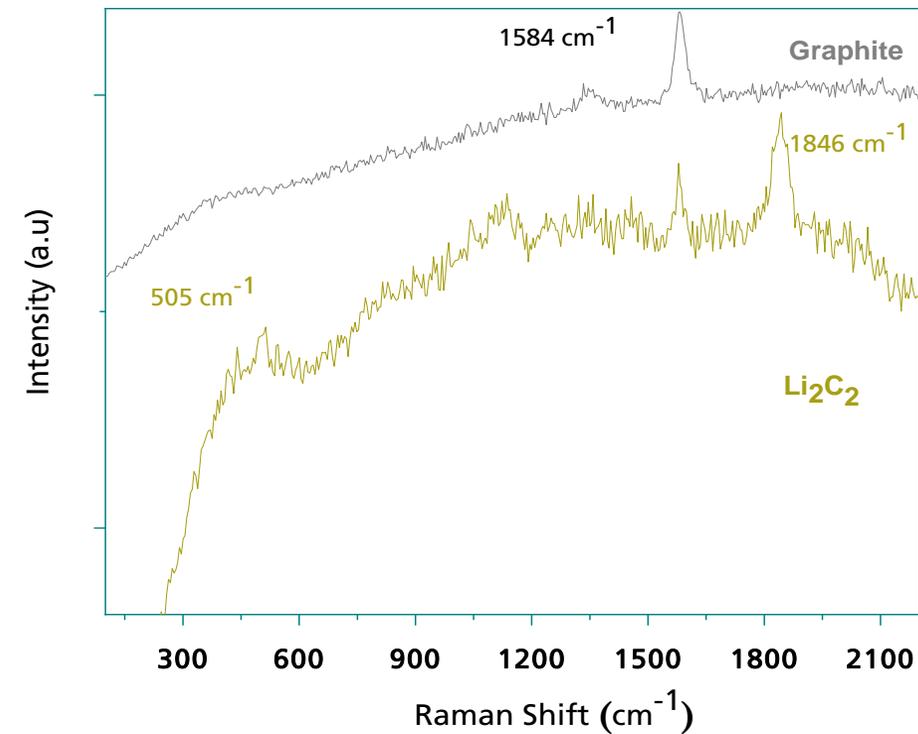
Raman results of aged graphite anode next to the tab – 250 cycles

- Raman mapping at the edge position

➔ Starting of aging with the appearance of Li_2C_2
