# NDT for Need Based Maintenance of Civil Infrastructure – FilameNDT a FrancoGerman Project for Monitoring and Inspection of Bridge Cables, Ropes and PreStressed Elements

Within the frame of the Franco-German project FilameNDT steel wires of external tendon ducts and prestressing strands, prestressing rods, and stay cables are investigated. Regarding this field of application, practical relevance can only be gained when easily applicable and long ranging methods can be used. Therefore, a global and a local approach were chosen. The evaluation of extended structural elements using non-contact movable systems (bulk wave and guided wave application (Piezo, Electro Magnetic Acoustic Transducers (EMAT)), Magnetic Flux Leakage (MFL), Micromagnetic methods) and those of localized elements based on elastic guided wave propagation – are complementary since they can be applied according to the various accessibility conditions of the tested objects. Inspection and monitoring scenarios were developed, hot spots identified, and lab tests as well as field tests were carried out. A real wire rope bridge in the Saarland region is provided for monitoring within the frame of the project. The overal

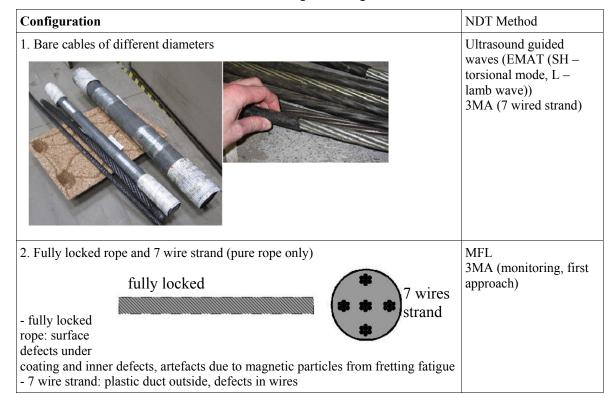
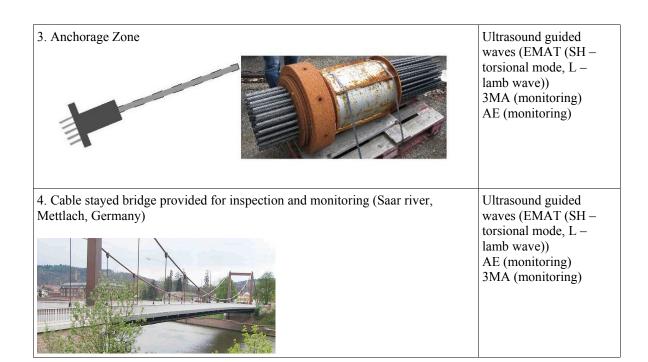
Table 1. Investigated configurations

Within the frame of the Franco-German project FilameNDT, several relevant elements of typical constructions requiring special attention in form of inspections or monitoring were identified. The most relevant ones are summarized in Table 1. Results from inspections and monitoring tests will be described within the frame of this paper of the configurations 1 to 4, whereas the bridge shown in configuration 4 represents a realistic test scenario.

The NDT methods listed in Table 1 were first applied to specimens in the laboratory environment. Then inspection and monitoring tests were carried out at the real bridge shown in configuration 4 of Table 1. Within this paper the focus is set to ultrasonic and micromagnetic methods which can be used either for inspections or for monitoring purposes. In the next sections the chosen approaches and the results will be described.

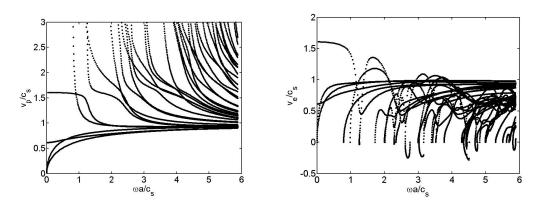
Figure 2. Calculated dispersions curve of guided wave modes in single z-shaped fiber (left: phase velocity; right: group velocity; a = 3 mm,  $c_s = 3.2 \text{ mm/}\mu s$ )

No coupling with adjacent wires has been considered. Due to the geometrical complexity, a numerical method must be used. Here the method is based on the so-called semi-analytical finite element technique, which consists in reducing the problem to the cross-section only, thanks to a spatial Fourier transform performed along the axis. With a Semi-Analytical Finite Element (SAFE) method, the only assumption required is that the structure must be translationally invariant, which is the case for a single z-shaped wire. The problem to be solved, initially three-dimensional, hence becomes two-dimensional. The curvature of the helical axis has been accounted to be based on the use of a specific curvilinear coordinate system, corresponding to a twisting system, recently developed at IFSTTAR. Results have shown that the curvature of the axis can be neglected for the structure and the frequency range considered. Some theoretical dispersion curves are presented in Figure 2, which plots, respectively, the dimensionless phase velocity and group velocity with respect to the dimensionless frequency for each propagating mode. The dimensional frequency range considered corresponds to the range [0 - 1 MHz]. It can be observed that many modes are propagating in this range. Typical for prismatic waveguides, compressional, torsional, and flexural modes occur. At this stage, additional information is needed for a proper identification of branch modes that are mainly excited with the experimental device (frequency, wavenumber and direction of excitation, ...). Interestingly, future works would consist in taking into account the excitation in the numerical model and plotting the corresponding dispersion diagrams.

For a single fibre of a z-shaped fully closed rope, the dispersion diagram was calculated (see section 2.2). Due to the results of the dispersion curves EMAT probes were designed and built for shear and longitudinal guided wave modes running in a single z-shaped fibre of a fully closed rope. Several EMATs with different trace wave lengths and corresponding frequencies were applied. The ultrasonic inspection parameters are shown in Table 3.

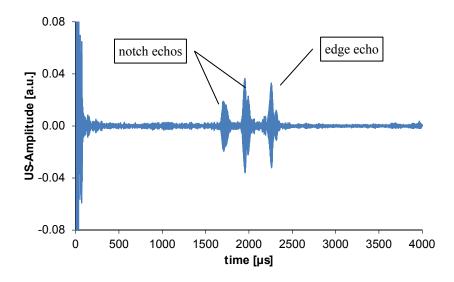
For the experiments on 7-wire strands EMAT probes were built up for the excitation and pick up of longitudinal and torsional guided wave modes. The principle design of the probes and the relevant ultrasonic inspection parameters are shown in Figure 3, respectively Table 2. The EMAT probes were applied to pre stressed and differently prepared 7-wire strands. The set of specimens contains coated strands with grease, concrete and free ones. In addition, a few wires were modified with artificial pitting or cracks like defects.

**Figure 3.** The principle design of EMAT probes for rod waves (left: torsional wave modes, right longitudinal wave modes)

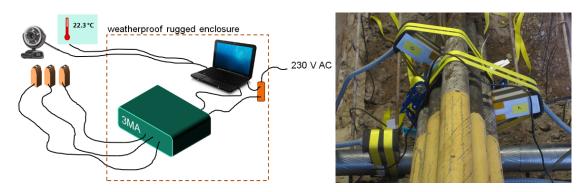
An on-site test of the micromagnetic monitoring approach was performed at the bridge over the Saar river in Mettlach, Germany. The applied measurement setup is shown in Figure 8. In order to test the remote flaw detection approach a set of three rugged micromagnetic devices was built, and an appropriate software for the long-term control of several devices with a single PC was created. A netbook PC, a USB hub for controlling the

devices, and the power supplies were placed in a weather-proof box. The unit was connected to the 230 V mains line, available at the construction site. Two devices were strapped on loaded bridge ropes, and one device was strapped on an unloaded fully locked wire rope of similar design. In order to monitor the environmental conditions (temperature, humidity) and the traffic load, a time lapse camera and a weather logger were installed as well.

**Figure 8.** Schematic representation of the monitoring equipment tested in Mettlach and photo of three installed devices (two on the loaded ropes and one device on an unloaded similar rope located below the loaded ropes)

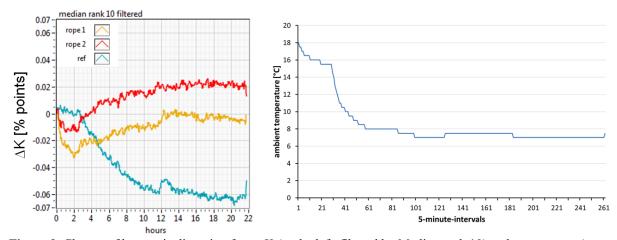
- A small, but significant correlation between the measured values and the ambient temperature was found (Figure 9). Further lab tests were performed which have shown that the effect is related to the temperature of the material, rather than the temperature of the device. A remarkable observation is that the temperature coefficient of the values measured on the loaded ropes had opposite sign and a smaller magnitude than the one in case of the reference rope. This suggests that the effect might be at least partially related to the thermal expansion of the wire and the related variations in tensile stress.

**Figure 9.** Change of harmonic distortion factor K (to the left, filtered by Median rank 10) and temperature (to the right) throughout the first experiment at the bridge

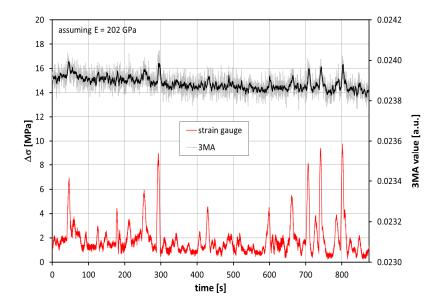
In a second on-site measurement, the actual effect of traffic was quantified using strain gauges, and the stress-sensitivity of the micromagnetic method was increased by tuning the device settings and analysis methods. Figure 10 shows the result. Assuming a Young's modulus of E = 202 GPa, the stress change  $\Delta\sigma$  was computed from the measured strain  $\epsilon$  (red curve). The micromagnetic materials characterization was performed using a 3MA device (3MA = Micromagnetic Multiparameter Microstructure and Stress Analysis), and the most stress sensitive parameter, derived from the incremental permeability measurement, was plotted over the same time axis as the strain gauge values (gray curve). In order to improve the signal/noise ratio, the 3MA signal was smoothed using a moving

average filter, resulting in the black curve. The results show that a strong correlation between strain gauge signal and micromagnetic signal exists. Each peak in the strain gauge results from heavy loaded vehicles like trucks. This was confirmed by camera observations of the traffic. The strain gauge was calibrated with tension tests in the laboratory. Theoretical calculations of the static load on the ropes, due to a truck passing the bridge, let to a value of 15 MPa. The measured values are in good accordance with this calculation. The result of the micromagnetic measurement, which was performed parallel to the strain gauge tests, show that all peaks in the strain gauge signal can also be resolved in the micromagnetic signal. This experiment indicates that the resolution limit of the micromagnetic measurement should be approximately in the same order of magnitude as the traffic load. Therefore, we can assume that it will be sufficient to detect probable wire breaks within the frame of these planned long term monitoring activities, since wire breaks would generate much greater stress changes than the observed traffic loads.

Figure 10. Strain gauge and micromagnetic signal of traffic load
