INTEGRATED LIGHTWEIGHT, GLASS-FREE PV MODULE TECHNOLOGY FOR BOX BODIES OF COMMERCIAL TRUCKS

Christoph Kutter[1], Felix Basler[1], Luis Eduardo Alanis[1], Jochen Markert[1], Martin Heinrich[1], Dirk Holger Neuhaus[1]
[1] Fraunhofer Institute for Solar Energy Systems ISE, Heidenhofstrasse 2, 79110 Freiburg, Germany
Corresponding author: Christoph Kutter | Phone: +49 (0)761 4588 2196 | e-mail: christoph.kutter@ise.fraunhofer.de

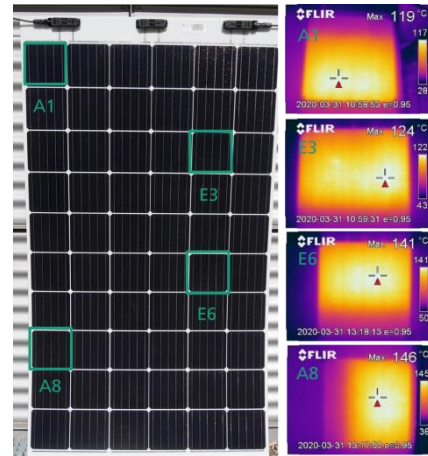
Insulation Test (MQT 03), and Wet leakage current test (MQT 15) were performed before and after a Hot-spot endurance test (MQT 09) on a 60-full-cell-laminate, (see Figure 3). The maximum cell temperature reached during the Hot-Spot endurance test was 146 °C when cell A8 was shaded 25 %.

No visual defects were found and the module passed Wet leakage and insulation tests afterwards.

Figure 3: Photo of module after Hot-Spot endurance test, with marked shaded cells. Infrared images of the respective shaded cell and highest measured temperatures during Hot-Spot endurance testing

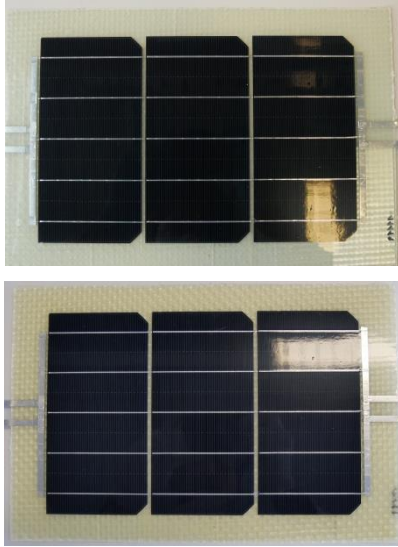
After aTC200 we found the half-cell laminates mechanically intact and no delamination of the encapsulation was observed. The GFRP exhibits minor

yellowing. Figure 4 shows a photographic comparison of a module before and after aTC200.

Figure 4: Photographs of a half-cell module initially (top) and after aTC200 (bottom)

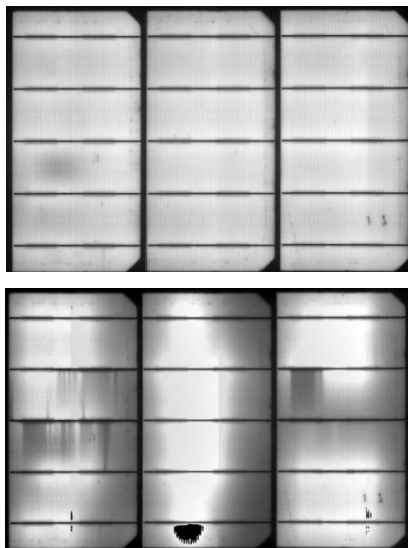
Electrically, we observe that the emitted light intensity of the half cells in electroluminescence (EL) images becomes more inhomogeneous (Fig. 5), due to two effects: finger failure and partial disconnected cell-interconnect-ribbons. [16, 17]

Finger failure typically indicates a high strain at the solder joint. It is commonly known that this kind of failure appears after thermomechanical stresses and lead to power losses in the TC test.

All cells tend to darken from the pseudo-square-edge, where the ribbon is led from the front side of the cell to the rear of the neighboring cell (Figure 5).

Figure 5: EL-images of 3-half-cell module before (top) and after aTC200 (bottom)

Our assumption is that the tested polymeric top cover in comparison to glass does not have enough rigidity to counterweight the ribbon compression-induced forces. Additionally, finger failure and ribbon disconnection effects are intensified due to the higher thermal expansion of the ETFE top cover, which is 9.4×10^{-5} K^{-1} [18] vs. 9×10^{-6} K^{-1} of soda-lime-glass [19]. Therefore the soldered joint between cell metallization and ribbon or cell is subject to fatigue failure at the cell edges in aTC.

The presented results indicate that for the proposed ETFE-GFRP module technology interconnection technologies that induce less mechanical stress, e.g. shingled or multi-wire connection through smaller wire diameters, might be beneficial for better TC performance. Multiwire modules have been observed to show better TC performance in other studies. [13]

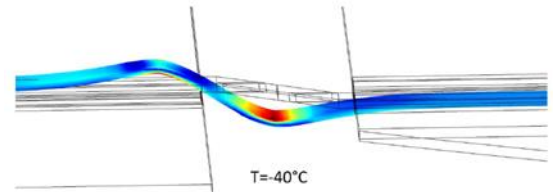
From Finite Element Modelling (FEM) of modules with polymeric top covers we know that ribbon tend to compress at -40 °C inducing vertical shear stress on the contact-metallization-interface (Figure 6).

Figure 6: FEM distortion result for a soldered ribbon at -40 °C with a polymer–based top cover (double scaled)

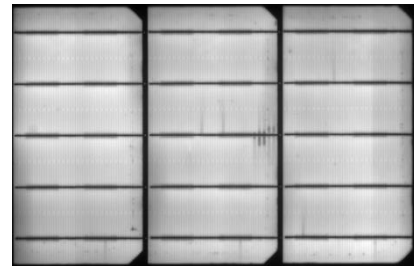
This is backed by the analysis of the reference module. We find the finger failure effect to be less strong in the reference module with glass-backsheet configuration. The ribbon disconnect effect is not present in the reference module after aTC200 (Figure 7).

Figure 7: EL-image of the glass-backsheet reference after aTC200

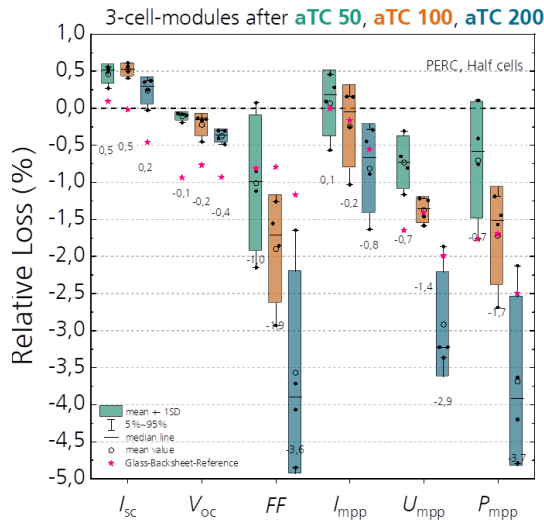
The box plot in Figure 8 illustrates the relative change of the electrical parameters of all four ETFE half-cell modules and the glass-backsheet reference for 50, 100 and 200 aTC cycles. We see a 0.2% increase of the I_{sc} and only a 0.4% decrease in V_{OC} after 200 cycles. Average fill factor (FF) of the ETFE-modules degrades strongly by 3.6 % after 200 cycles, resulting in a 3.7 % average reduction of module power P_{MPP} compared to 2.5 % for the reference module.

The high drop in FF is typical when an increase of series resistance happens, which is the case for the two observed failure modes (finger failure and partial disconnected interconnection ribbons).

Figure 8: Relative losses after aTC – aging of half-cell-modules

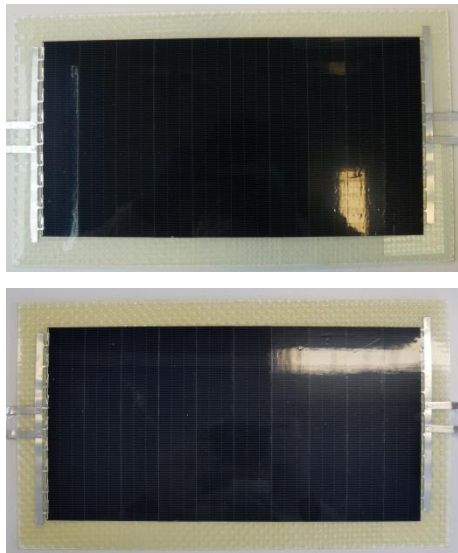
After aTC200 aging of the shingle modules we find the module configuration to remain intact, with no delamination observed (Figure 10). The front ETFE foil, as well as the rear GFRP cover, shows no damage. Again, the GFRP shows a minor yellowing.

Figure 9: shingle-cell module (ID 11173) initially (top) and after aTC200 (middle)

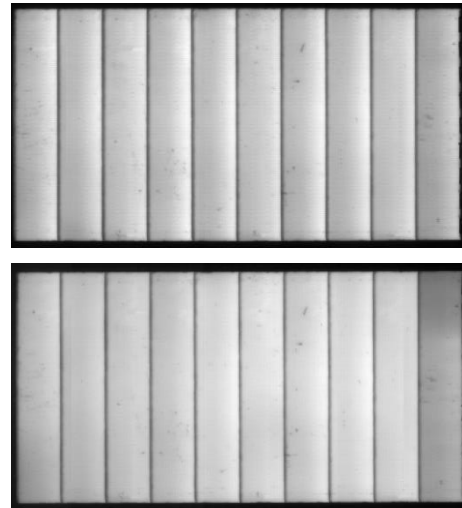
After aTC200 aging of the shingle modules we observe a much more homogenous EL image of the modules as compared to the half-cell samples (Figure 11). There are no finger defects visible, which confirms our presumption that the ribbons are likely to cause the finger defects within conventional soldered ribbon technology.

Figure 10: EL-images of 10-shingle-cell module initially (top) and after aTC200 (bottom)

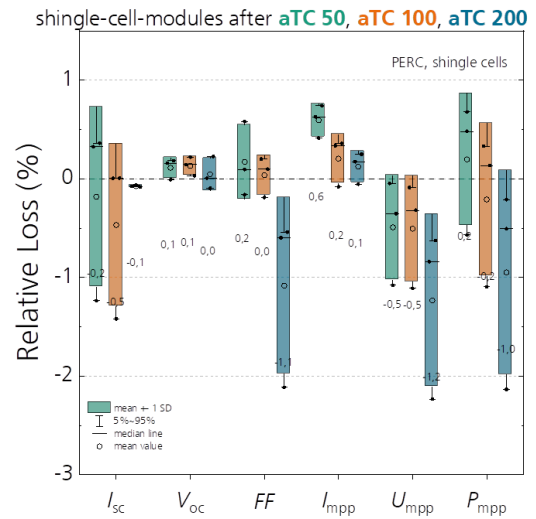
The promising EL images are backed by electrical measurements shown in Figure 11. Relative mean power drop in P_{MPP} is only 1 %. These findings are in good accordance with aTC results of shingle interconnection technologies reported by Schiller et al. [13]

Figure 11: relative losses after aTC – aging of shingle modules

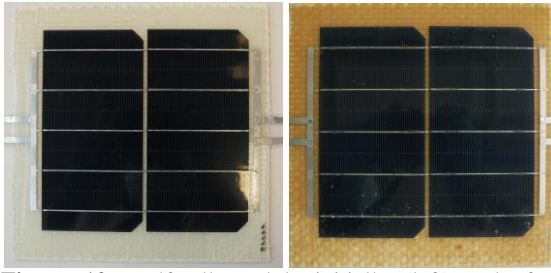
After 1,500 h of DH exposure we observe visible deterioration of the module compounds due to embrittlement of the GFRP (Figure 12). The cell and cross connectors show partial corrosion and small areas of delamination on top of the corroded cell connectors can be observed.

Figure 12: Half-cell module initially (left) and after DH1,500 (right)

We expect that the sandwich elements framed and sealed within the box body (Figure 18) will see much less exposure to humidity, therefore embrittlement of the GFRP should be less relevant. Furthermore, applying a gelcoat to the exposed surfaces of the GFRP is a well-known approach to improve weather stability of GFRP [21].

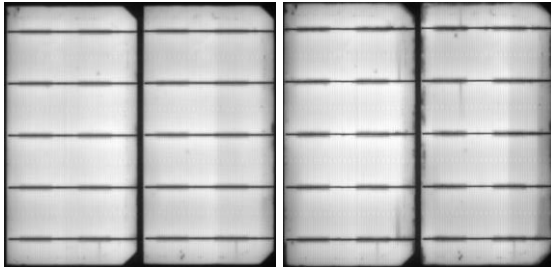
The EL images in Figure 13 after DH1,500 show signs of corrosion at cell edges as well as the cell connector edges.

Figure 13: EL-image of a half-cell module initially (left) and after DH1500 (right)

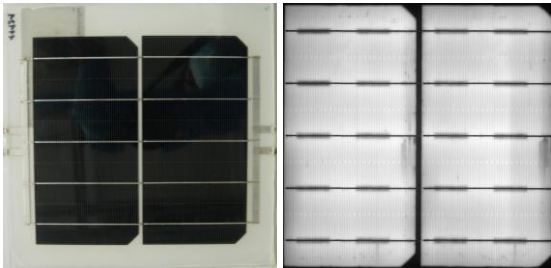
We find similar deterioration effects after DH1500 in the glass-backsheet-reference (Figure 14).

Figure 14: Photograph (left) and EL image (right) of glass-backsheet reference after DH1500

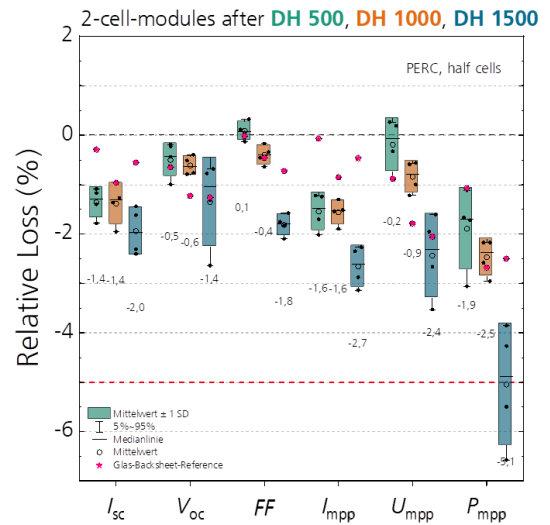
Analyzing the mean relative losses of the electrical module parameters in Figure 15, we observe a mean P_{MPP} change of -5 % after DH1500 (-2.5 % after DH1000), which is -2.5 % more than the glass-backsheet reference module.

Figure 15: relative losses after DH – aging of half-cell-modules

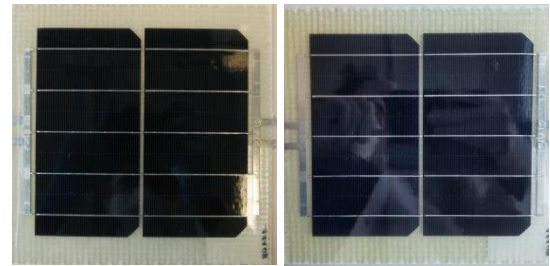
Figure 16: Half-cell module initially (left) and after UV 60 kWh/m² (right)

We found no visible deterioration of the module compounds after conditioning with 60 kWh/m² (Figure 16). Although by visual inspection and EL imaging no damages could be identified, average module power output drops by 2 % while FF slightly increases (Figure

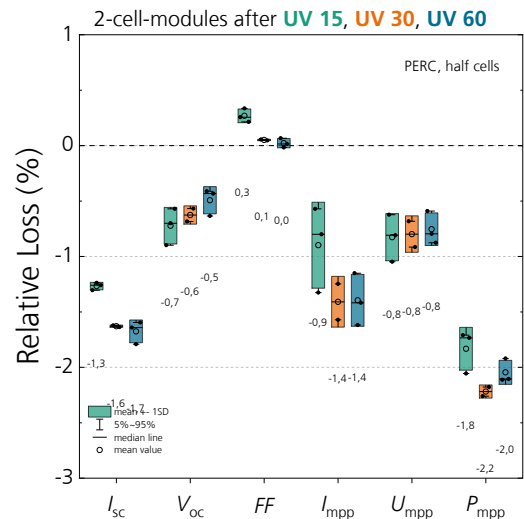
Figure 17: Relative losses after UV-aging

17). This is only possible since I_{sc} drops quite significantly by 1.7 %. A possible reason could be degradation within the EVA encapsulant resulting in increased absorption or reflection within the EVA layer. Further validation experiments to identify the degradation mechanisms are planned.

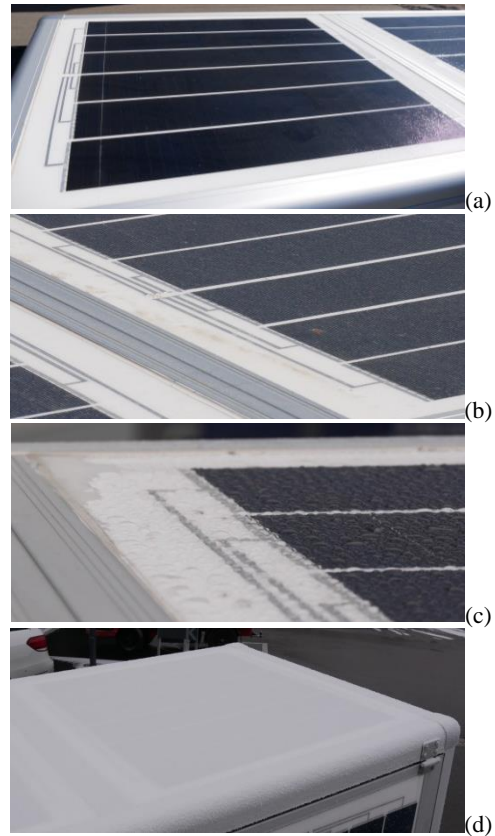
The truck is monthly monitored by visual inspection and every half year the modules are tested using EL imaging to detect any ageing effects. During the 10 months of outdoor exposure (September 19 – July 20), the modules have experienced different environmental loads such as high irradiation at elevated ambient temperatures, snow, rain, heat and soiling (Figure 19).

It was found that the module setup withstands the observed conditions robustly. After 10 months of operation no delamination is observed, the cover foils remain intact.

Figure 19: Environmental loads: High irradiation at ambient temperatures of >35°C during summer 2020 (a); soiling due to pollen during spring 2020 (b): rain (c) and snow cover during winter 2020 (d)

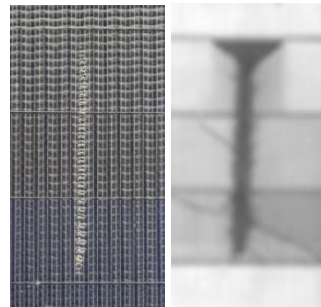
Further minor damages have been found where an external mechanical force was certainly at play (Figure **20**).

Figure 20: Scratch on the surface of the ETFE foil (left) damaged cells in the EL image (right)

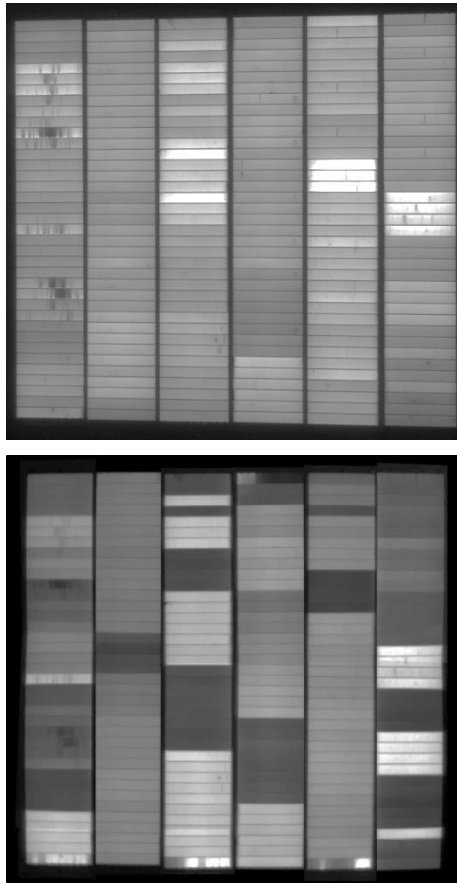
With the EL imaging we find that the emitted radiation levels of the shingled solar cells become more inhomogeneous in the EL image after environmental exposure (Figure 21). This might indicate a deterioration process of the cells or the ECA joint. The shingled solar cells remain mechanically intact. We would like to highlight that unlike the minimodules that were put into the ageing experiment featured optimized cells and enhanced ECAs, the modules in this section have been manufactured with first generation cells and non-optimized processes. Therefore, new exposure experiments on vehicles with the enhanced bill of materials are planned.

Figure 21: Module 5, EL image taken with *Great Eyes EL* system in a dark chamber after lamination in Sep. 19 (top), El image in July 2020 taken with *Xenics InGaAs* camera outdoors (bottom)
