## **ABSTRACT**

C.-H. Kuo<sup>1)</sup>, A. Leber<sup>2)</sup>, C.-M. Kuo<sup>1)</sup>, C. Boller<sup>1) 2)</sup>, C. Eschmann<sup>2)</sup>, J. Kurz<sup>2)</sup>: <sup>1)</sup> Saarland University, Mat. Sc. & Technol. Dep., Chair in NDT & QS; <sup>2)</sup> Fraunhofer Institute for Nondestructive Testing - IZFP, Saarbrücken / Germany

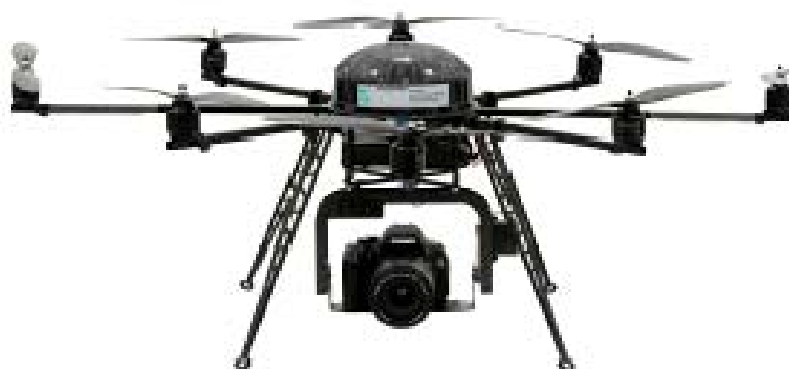
The inspection method used is based on a MAV as an octocopter equipped with a digital camera underneath as shown in Fig. 1. The MAV is flown remotely and scans the building to be monitored. The camera is set to be continuously triggered with a frequency of 3Hz, which is also known as the time based method of image capturing. Even though the robot is fitted with a GPS receiver and has GPS guided capability, the entire flight process is manually controlled. This is due to the lack of signal when the vehicle flies close to a wall. The autopilot only provides auto-stabilization and altitude hold.

Fig. 1 Octocopter MAV system with digital camera

A eight rotors micro-helicopter (octocopter) as shown in Fig. 1 was selected as the inspection robot. It offers sufficient payload capacity, is small in size, and most importantly it consists of a simple mechanical structure. The digital camera is a 12 megapixel Cannon SX230 with an image ratio of 4:3. Manual image stitching was selected for the whole process. The stitching process was split into different floors to fit to the monitoring approach. The overall stitched facade images were around 30 gigapixels. In addition some detailed photos were captured of damaged areas on the top floor which was inaccessible by the conventional inspection method. The building consists of many 2D facades which may cause confusion when all facades are displayed on one page. Thus a simple 3D interactive model was generated by combining the overall stitched images in a CAD software (Fig. 5).

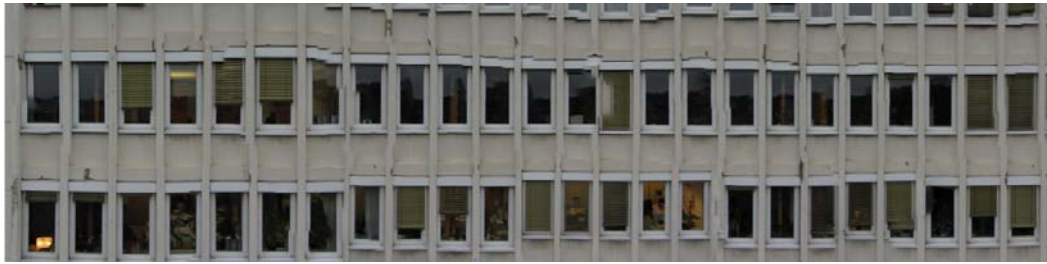
Fig. 3. Results obtained with partial automatic stitching, Note that window size changes are due to movement of the helicopter during flight.

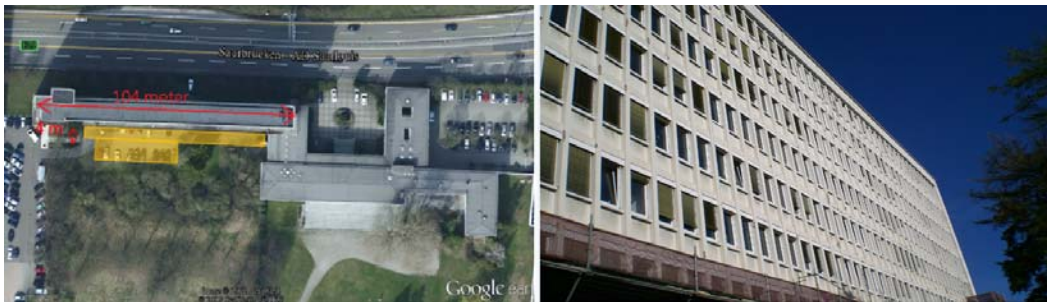
The approach described above has been applied to a major listed building which has been built more than fifty years ago. The building consists of 7 floors (around 30 meters high) and is around 100 meters wide. Each floor has a very similar visual image consisting of 70 windows each. A view onto the building is shown on Fig. 4.

Fig. 4 Building monitored, aerial view (left), front view (right)

Due to lack of quality and maintenance as well as the cost incurred concrete portions can currently come off the building. The building is therefore inspected at regular intervals where cracks are recorded and mapped manually into a drawing while loosening concrete portions are removed at the same time. This work is so far only possible by moving an inspector with a fairly large lift along the building, which is an extremely cost and time consuming process that cannot be repeated too often. Access to the building has been rather limited as might be recognized from the aerial view on Fig. 4 (left).

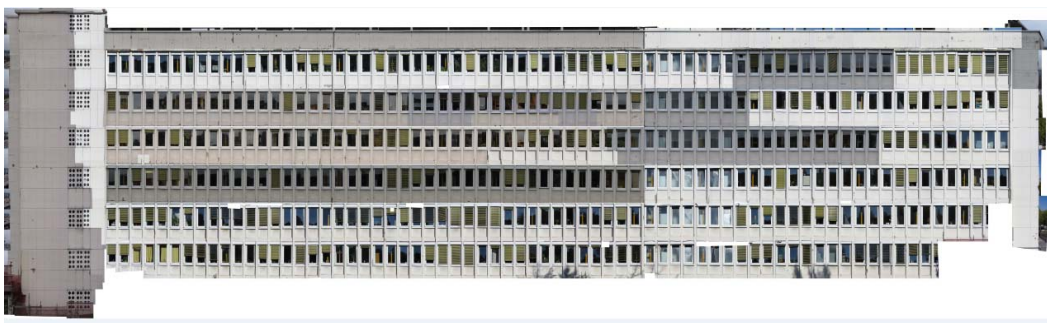
Fig. 6 Fully stitched image of the building to be monitored

shows the complete image of the façade of the building monitored. It is worth noting that there are light and dark patches on the image. Those result from the fact that the building was recorded twice and this at different weather and hence illumination conditions. This proves that the procedure has even the flavor that any updates regarding recordings can be included at virtually any time without having the building

to be completely scanned again. Another observation that can be made is that not all of the building at the bottom can be seen. This results from the fact that the MAV has to fly at a certain distance above the ground which does not allow the adequate pictures to be taken from the bottom portion of the building. The same applies with regard to bushes and trees close by the building where the MAV is not able to fly because of space as well as possibly even aerodynamic reasons. Recording of the bottom sections of a building may however be achieved by using a ground vehicle travelling in front of the building with a camera system and with the help of a telescopic extension enabling even different photographic traces to be taken at high resolution allowing large sections of a building's bottom to be monitored.

working days consisting of an inspector with a basket lift who track moves along the facade of the building with visual inspection but no digital data recording. Fig. 6

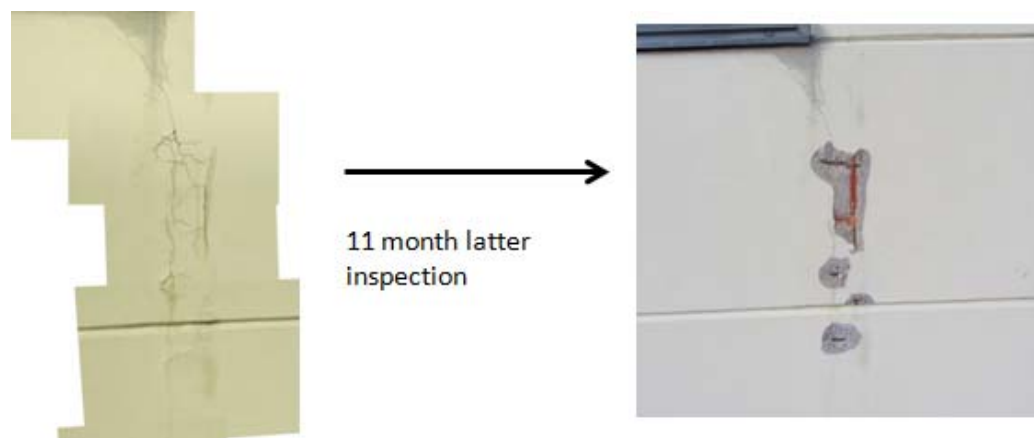
The option to stitch selected images even into a complete image of a building has the specific flavor that histograms can be established for selected areas prone to damage or where damage gradually progresses. An example of such a progressing damage is shown in Fig. 7, where the same location has been monitored within distance of 11 months. What has been seen as a slight crack pattern initially has turned out to break off some months later. Such a time series of pictures allows damage propagation to be observed in a first place. This is specifically important with concrete structures where processes of damage propagation are much less known and design configurations applied are various. With the approach proposed here a database of damage accumulation case studies can be provided that can serve for any kind of validation in excess of monitoring buildings in accordance to state of the art techniques. The approach is furthermore useful for facility management when facilities may be spread over hundreds of kilometers and more.

Fig. 7. Historical image for damaged area (11 months apart)

Assessing buildings in terms of their damage condition in the way described here however does not only require automated image stitching to enhance the monitoring process. What is further required is an automated pattern recognition procedure that allows damage patterns to be recognized and quantified such as it is shown on the left hand side picture on Fig. 7. Parameters may be derived that will
