Susceptibility of COTS sensors to IEMI using pulse modulated signals

Louis Cesbron Lavau¹, Michael Suhrke¹, Peter Knott²

¹Electromagnetic Effects and Threats, Fraunhofer Institute for Technological Trend Analysis INT, Euskirchen ² Chair of Radar Systems Engineering Institute of High Frequency Technology, RWTH Aachen Fraunhofer Institute for High Frequency Physics and Radar Techniques FHR, Wachtberg

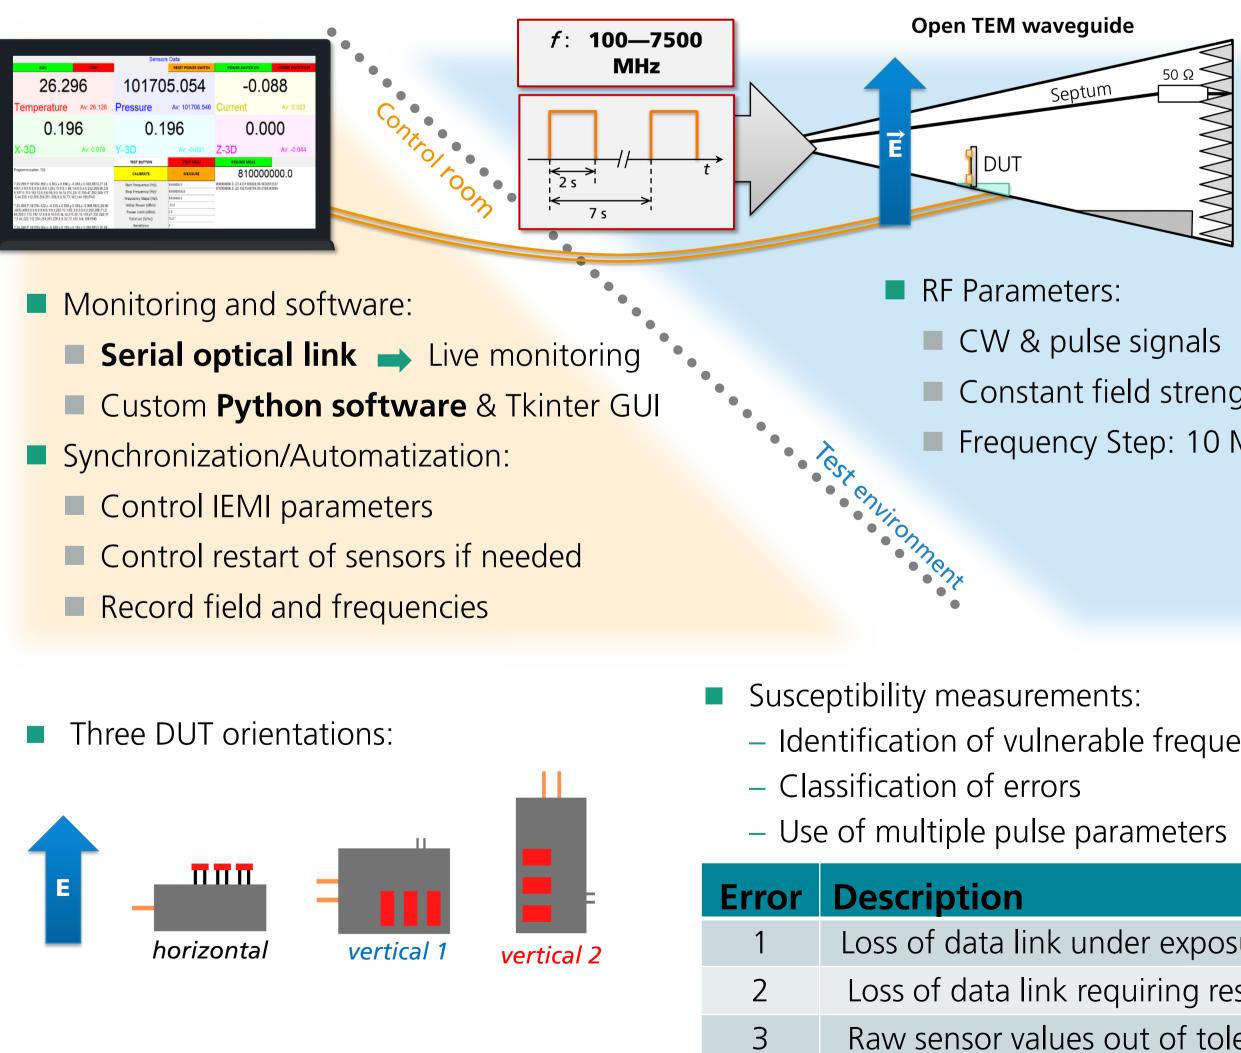
Open TEM waveguide

CW & pulse signals Constant field strength Frequency Step: 10 MHz

- Identification of vulnerable frequencies

Loss of data link under exposure Loss of data link requiring restart Raw sensor values out of tolerance Sensor status errors

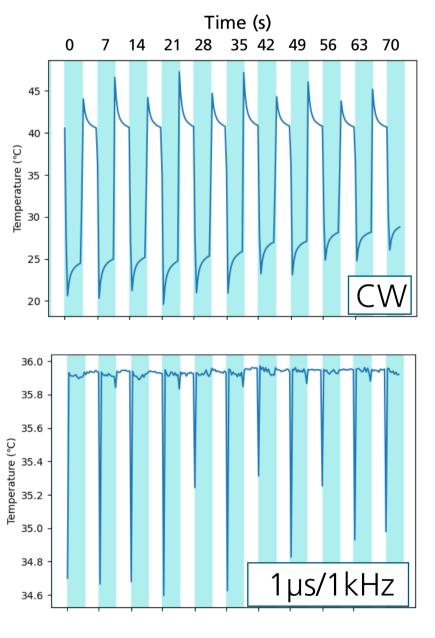
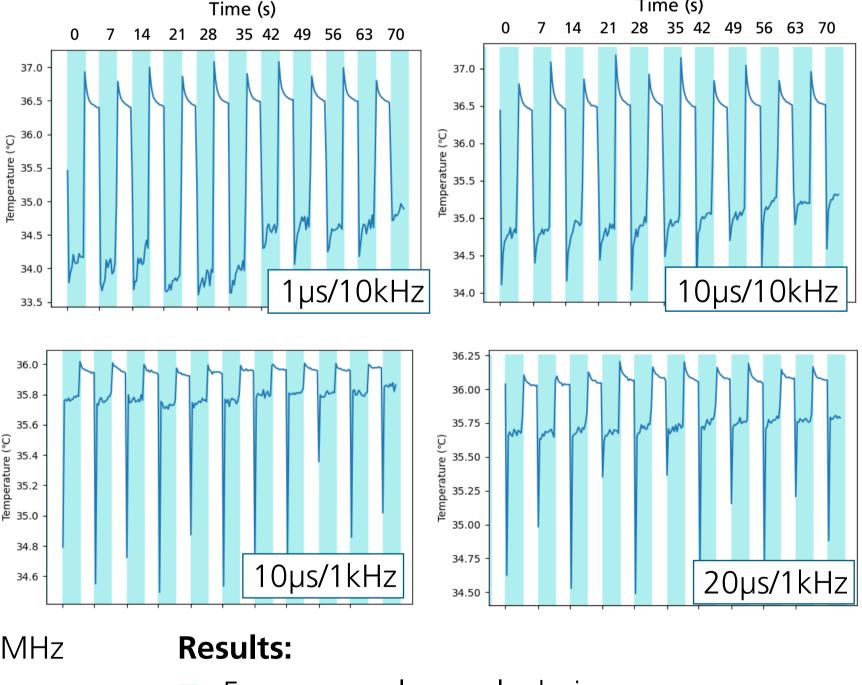
Influence of pulse parameters on the measured temperature (barometer)

Frequency range: 5900 – 6000 MHz Field : 400 V/m **RF exposure:** 2 seconds (plot:)

Signal parameters:

- Continuous Wave (CW)
- 2. Different pulse parameters:
- pulse width : 1µs, 10µs & 20µs – pulse repetition rate (PRR) :
- 1 kHz & 10 kHz

- Significant changes of indicated temperature with CW signals
- Various influences of pulse parameters: Shorter pulse width -> narrower peak
- qualitatively, not quantitatively

- Erroneous values only during exposure No status errors
- Higher PRR -> similar behavior to CW
