Thermal and corrosion properties of silicon nitride for copper die casting components

Iyas Khader^{* a,b}, Alexander Renz^b, Andreas Kailer^b, Daniel Haas^c

Abstract

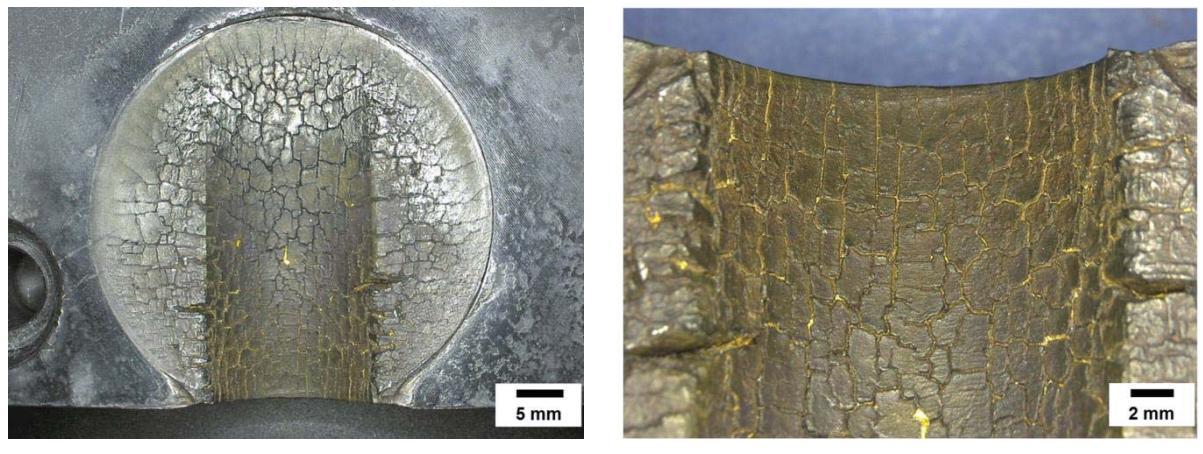
Figure 1. Stereo-microscope images of a steel die-insert hot runner showing (a) thermal fatigue induced cracks; (b) a close-up of the damaged surface and residues of molten material ($CuZn_{16}Si_4$ -C) in the crack openings (Breuckmann GmbH & Co. KG)

Thermal fatigue cracking, decarburisation, softening and formation and dissolution of intermetallic layers are the principle failure mechanisms of die casting tooling components (i.e., shot sleeves, hot runners, dies and moulds) [3-6]. Thermal fatigue cracking, also known as heat checking (Fig. 1), results from the rapid cyclic expansion of the surface material in contact with the molten metal and the expansion constraints imposed by the much cooler bulk material. During cooling, the temperature of the surface falls down below that of the bulk resulting in high surface tensile stresses that may exceed the strength of the material causing crack formation. Such extreme surface thermal loading causes early tool damage, which may be even exacerbated by chemical attack of the melt.

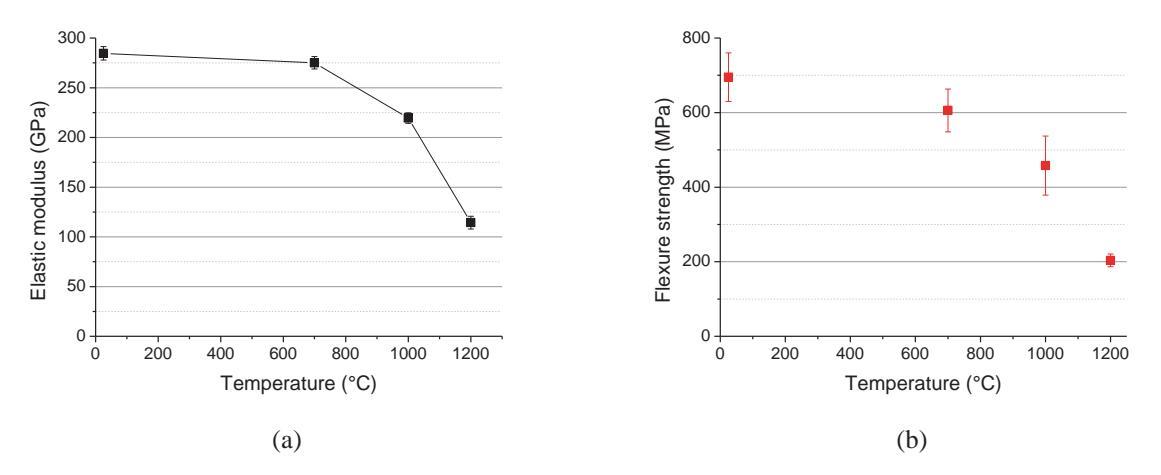
Figure 2. (a) Temperature dependent elastic modulus of FSNI; error bars indicate the standard deviation for at least five specimens, the lines connecting the dots represent linear interpolation; (b) four-point bending strength; error bars indicate the standard deviation for at least five specimens

Preliminary tests were carried out to characterise basic ceramic material properties. Fig. 2 shows the elastic modulus and four-point bending strength as a function of temperature. The measurements were carried out at room temperature, 700, 1000 and 1200 °C.

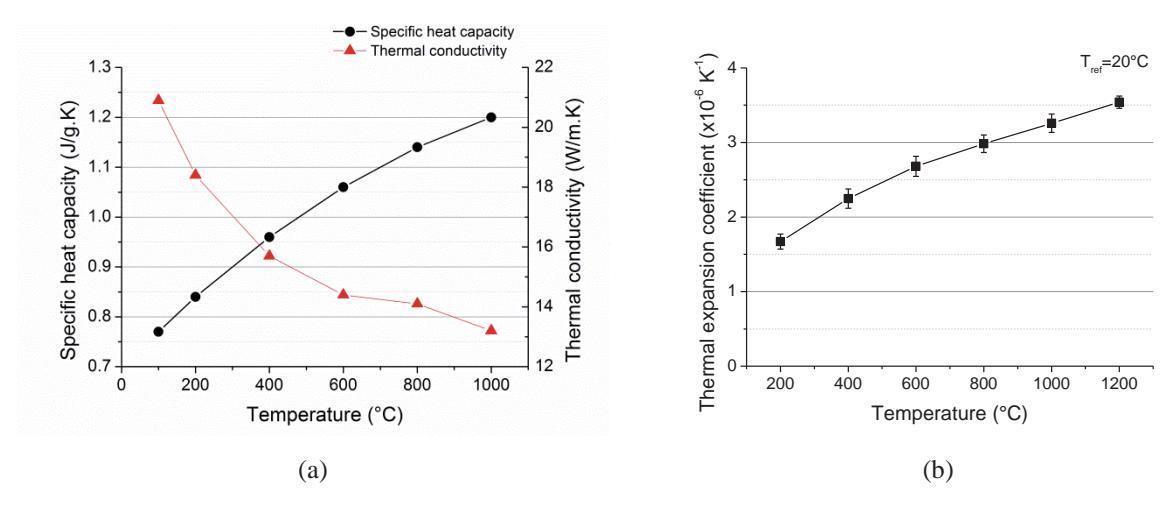
Figure 3. (a) Temperature dependent thermal conductivity and specific heat; (b) Temperature dependent coefficient of thermal expansion. Lines connecting the dots represent linear interpolation

Fig. 3 shows the thermal conductivity, specific heat and coefficient of thermal expansion as a function of

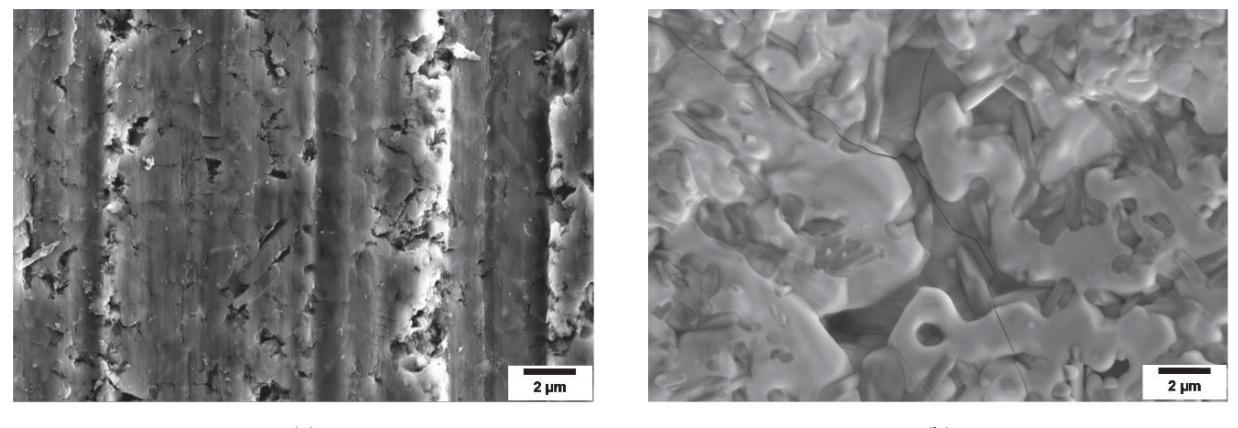
Figure 4. SEM image of the surface of FSNI in (a) its virgin state; (b) after 10,000 cycles in air at 1200 °C/ air at RT

The specimens did not show any signs of colouration or pitting after running the experiments, additionally, no visible macrocracking was observed. Scanning electron microscopy (SEM) showed distinct morphological changes to the surface of the specimens and the formation of a network of minute microcracks as shown in Figure 4.

In addition to the changes observed in the surface texture (Fig. 4b), the chemical composition of the surface layer showed higher concentrations of sintering additives compared to the bulk (Table 2). The most likely reason is a phase separation and accumulation of additive-rich oxides in direct contact with the melt and/or atmosphere. These yttrium-containing phases may include Y_2O_3 or $Y_2Si_2O_7$ [17],[18]. Considering the amounts of secondary-phase elements found in the oxide layer (refer to Table 2), there is no conclusive evidence that the glassy intergranular phase is leached out from the un-oxidised bulk material into the oxide layer. The oxide layers appeared inhomogeneous; brighter regions showed higher concentrations of yttrium (Fig. 5b), whereas the darker layer mostly contained silica. This phase separation and possible formation of oxynitride phases (e.g., Si₂ON₂) may influence oxidation significantly by affecting oxygen diffusion [19]. A detailed analysis of the reaction kinetics is, however, beyond the scope of the present study.

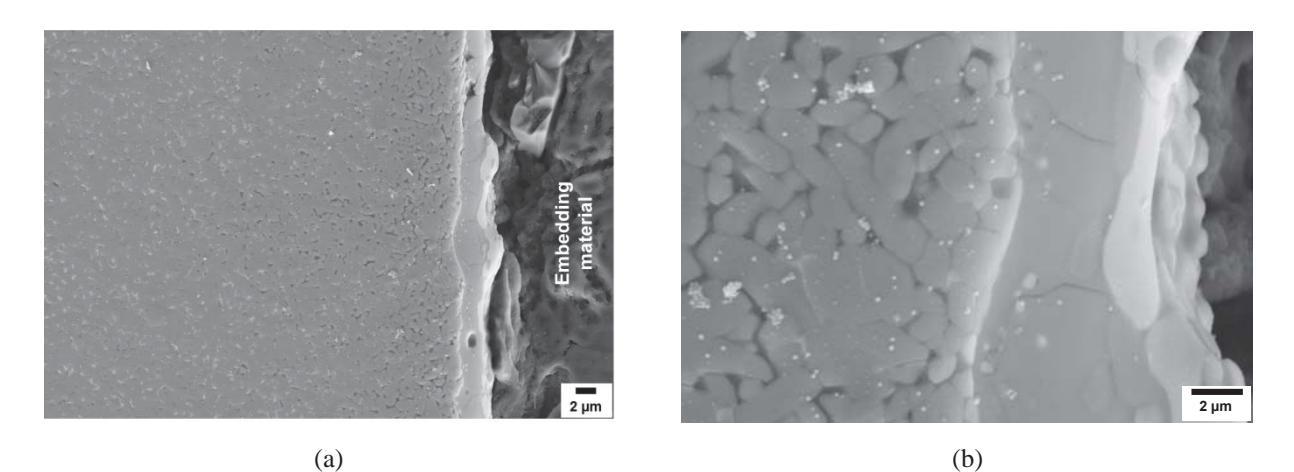
Figure 5. Cross-sectional SEM image after 10,000 cycles in air at 1200 °C/ air at RT (a) formation of silicon oxide layer; (b) detailed view showing different phases within the oxide layer

SEM/EDX cross-sectional analysis of the specimens after 10,000 heating and cooling cycles clearly showed the formation of an oxide layer on the surface (Fig. 5a). Moreover, this surface oxide layer appeared to be composed of different phases (Fig. 5b).

Analysis of the chemical composition indicated higher concentrations of Y in the utmost outer brighter layer (40% O; 30% Y; less than 15% Si). The darker inner region was mostly composed of silica (52% O; 38% Si; less that 2% Al).

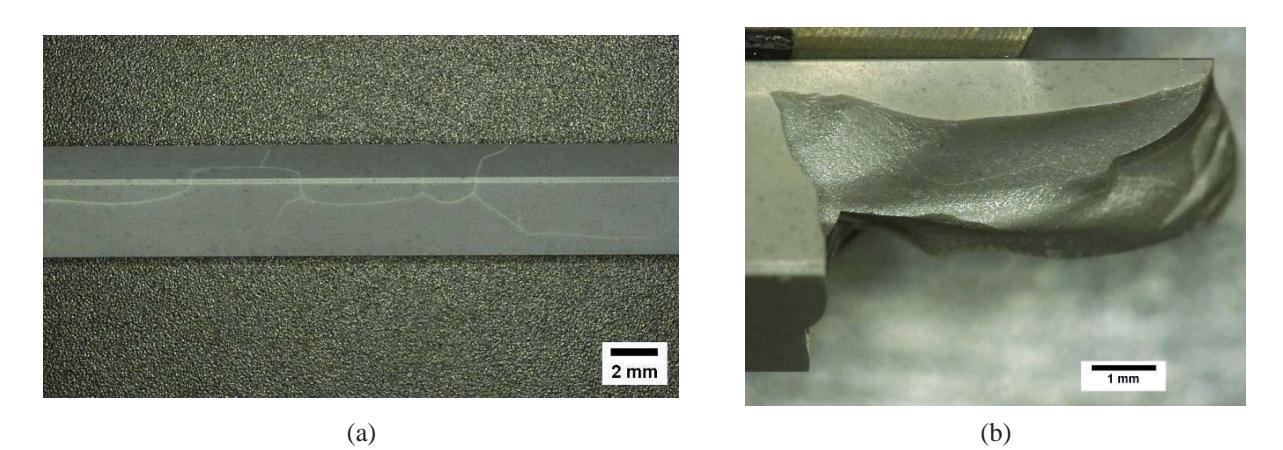
Figure 6. Crack formation due to thermal shock (a) after 150 cycles in air at 1200 $^{\circ}$ C / water at RT; (b) after 10,000 cycles in air at 1200 $^{\circ}$ C / water at RT; fracture surface appears shiny due to the formation of silicon oxide

The specimens quenched in water at 21°C showed a different behaviour; cracks initiating at the edges and propagating towards the centre of the specimens appeared on the surface after a low number of cycles (e.g., 150 cycles in Fig. 6a). By reaching 10,000 cycles most of the specimens have undergone complete fracture (Fig. 6b).

The fracture surfaces appeared shiny, as shown in Fig. 6b, EDX analysis showed high oxygen content indicating silica build-up. The re-crystallisation of the glassy intergranular phase in the form of yttrium-containing needle-shaped particles was also observed on the surface (Fig. 7).

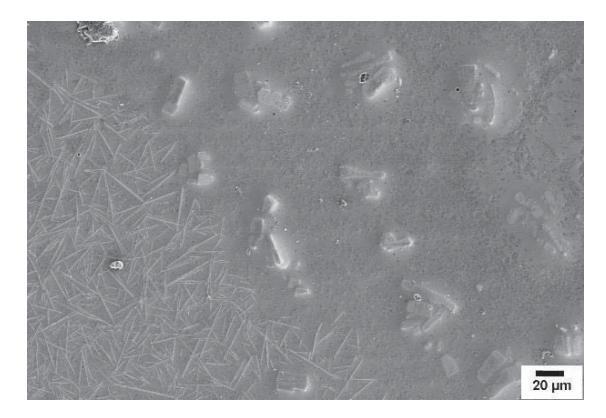
Figure 7. SEM of the fracture surface after 10,000 cycles air at 1200 $^{\circ}$ C / water at RT showing re-crystallisation of secondary phase (EDX results: needle-shaped particles: Y, O; glassy surface: Si, O)

The formation of crystalline yttrium-containing products was observed on the examined fracture surfaces after quenching the specimens in water (Fig. 7). A similar observation was documented in [17] following an oxidising heat treatment and in [20] after post-sintering heat treatment of Y_2O_3 -Al₂O₃ containing silicon nitride ceramics. The high cooling rates also lead to crack formation and premature fracture of the specimens before even completing the 10^4 cycles. Crack formation and material resistance to thermal shock are directly related to the thermal shock parameter *R* (equation 1) due to the high cooling rate. In addition to the macrocracks visible in Fig. 6, which indicate typical thermal shock fracture patterns that start at the edges; microcracks were also visible throughout the silica covered fracture surfaces (Fig. 8) due to the different expansion and contraction strains undergone by the surface and the bulk.

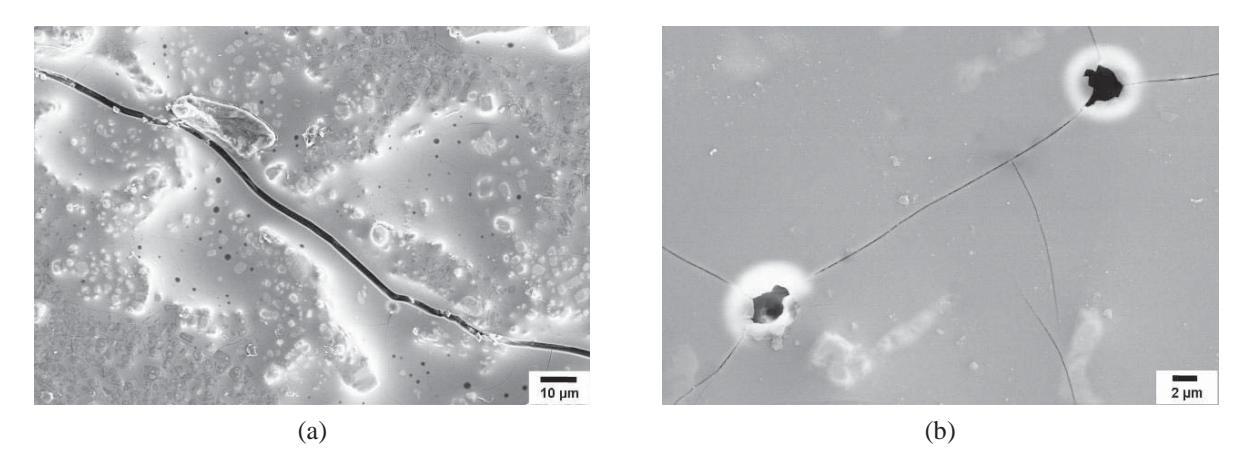
Figure 8. Fracture surface after 150 cycles in air at 1200 $^{\circ}$ C / water at RT showing (a) formation of silicon oxide, microcracking and recrystallisation of secondary phase; (b) formation of micropores at crack coalescence points

Microcracks and micropores also formed on the surface as shown in Fig. 8a. A more detailed inspection of these pores showed voids formed at crack coalescence nodes (Fig. 8b). It is also noticeable that round shaped holes appeared in regions of thick oxide layers around the crack openings (Fig. 8a).

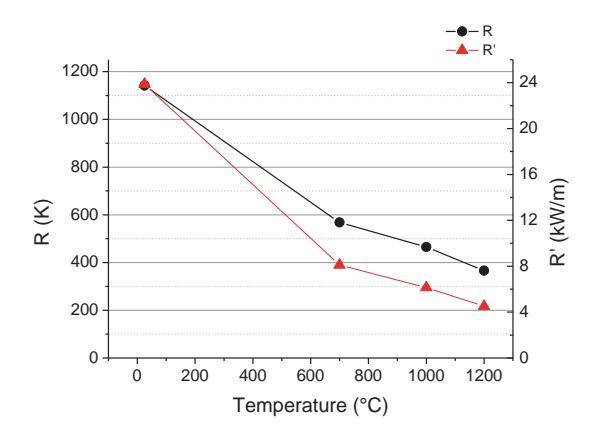
Figure 9. Thermal shock parameters for FSNI

The parameter *R* is applicable for instantaneous change in surface temperature for conditions of rapid heat transfer. This resembles quenching in water as explained in Section 3.2. The parameter *R'*, on the other hand, applies to low Biot numbers (β <2) for conditions of slow heat transfer [16], which resembles slow cooling rate by natural convection in air (Section 3.1). A summary of the thermal shock parameters is given in Fig. 9.

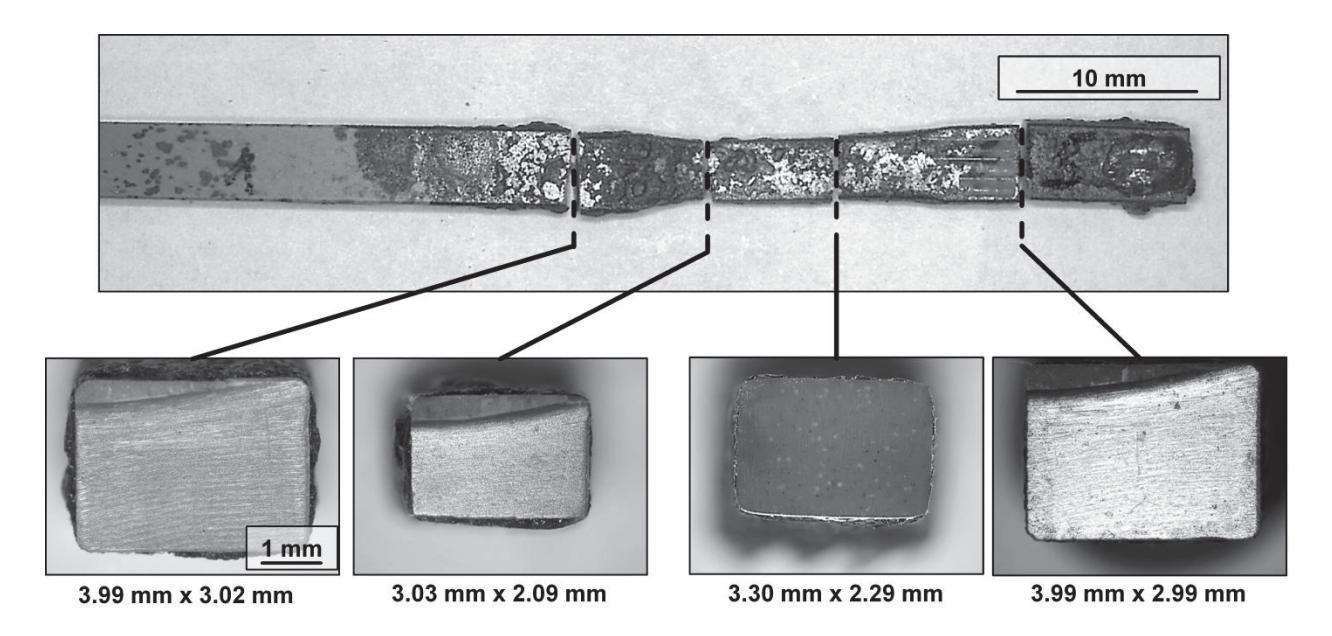
Figure 10. Overview and cross sections of a silicon nitride specimen after only 30 s of partial submersion in molten copper in air atmosphere A cross-sectional analysis of the specimen shows that the section closest to the surface of the molten metal, where a thick layer of slag builds up, was mostly affected by corrosion and material loss. The parts of the specimen fully submerged in copper showed significantly less corrosion, thus, less change in dimensions.

The specimens submerged in molten copper in air atmosphere showed distinct signs of corrosions. An example of a specimen partially submerged for 30 s only is shown in Fig. 10.

Fig. 10 clearly depicts that the middle section of the specimen, which was at the same level with the surface of the melt (i.e., in contact with the slag) suffered the most from corrosion and material loss, whereas the lower portion of the specimen, which was fully submerged in copper showed much less corrosion effects.

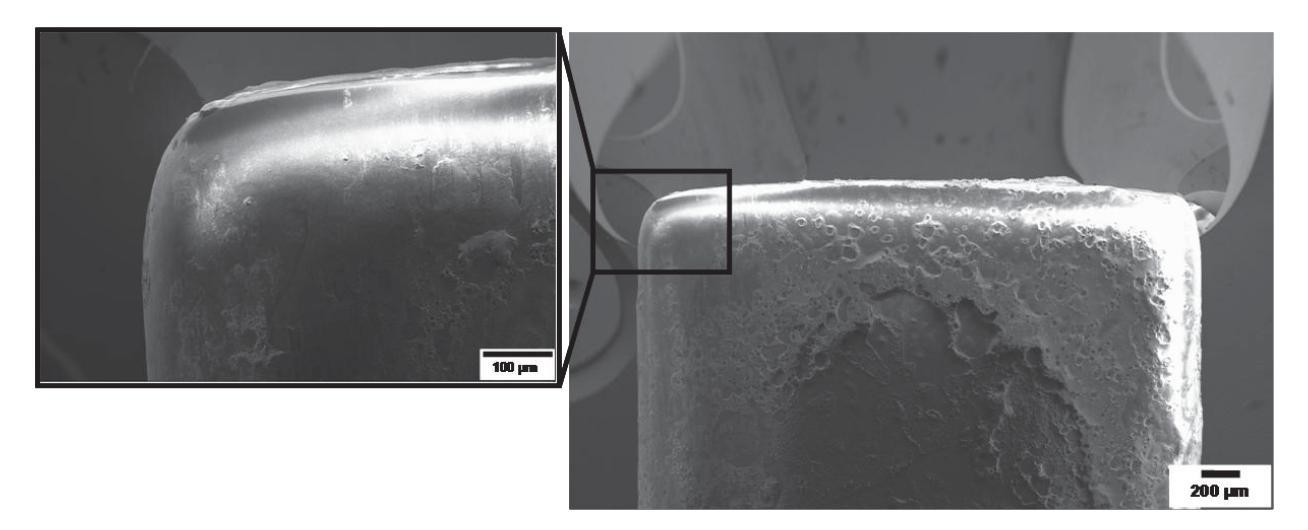
Figure 11. Blunted edges of a specimen partially submerged in molten copper at 1200 °C in air for 10 cycles each lasted 20s; blunted edges as a result of cyclic submersion

Cyclic submersion in the molten copper resulted in blunting the edges of the specimen despite the short contact period (Fig. 11).

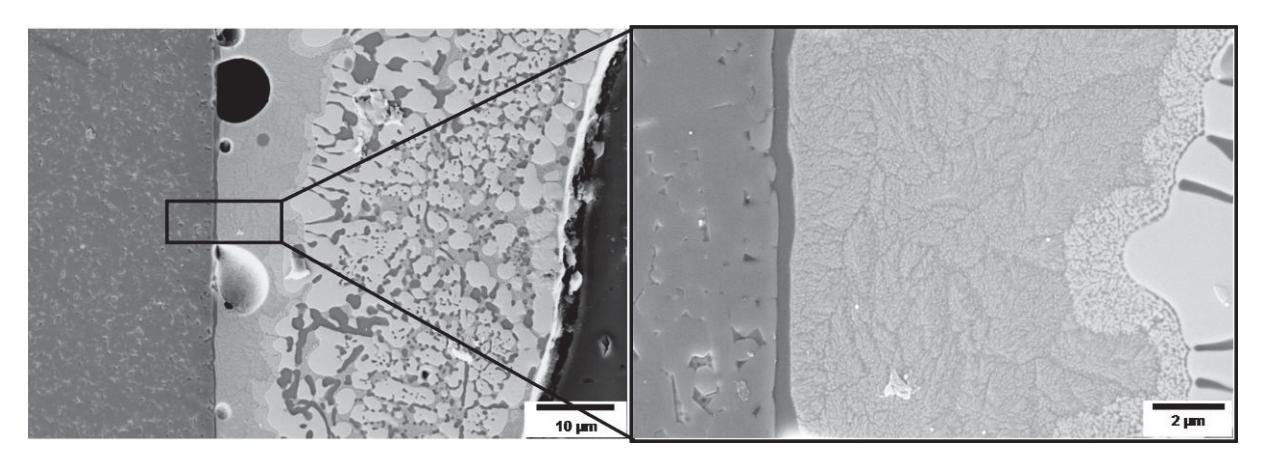
Figure 12. Surface layers of a specimen after submersion in molten copper at 1200 °C for 30s in air atmosphere; notice the formation of gas bubbles at the interface

Worth noticing is the formation of large voids due to a chemical reaction resulting in the discharge of gas bubbles. An EDX mapping of the near surface zone was conducted to identify the composition of the different layers (Fig. 13).

The silica layer formed during oxidation acts as a passivation layer that protects the ceramic from further oxidation or corrosion (second layer from the left in Fig. 12). In the absence of tribological and/or mechanical loading, the formation of an oxide layer on the surface of silicon nitride will help protect the surface from further exposure to copper oxide and hence hamper possible further reaction (Khader et al. [15]). SiO₂ in a Si-Cu-O system (refer to **Raman spectroscopy shown in Fig. 17 and summarized in Table 4**), however, starts melting at around 1150 °C according to the phase diagram proposed by Uet'yantsev et al. [22]. The high temperature of molten copper (~1200 °C) causes the silica layer to melt leaving the surface of silicon nitride exposed and therefore, permitting further oxidation (compare the silica layers in Fig. 12 and Fig. 15). The gases released in this oxidation process will also try to escape (or diffuse) through the formed superficial oxide layers. The formation of N₂ bubbles as a result of the oxidation of Si₃N₄ was thoroughly discussed by Luthra [23] and considered in the implementation of a mathematical model for the growth rate of porous oxide layers on Si₃N₄ by Galanov et al. in [24]. Both Fig. 12 and Fig. 16 show voids formed due to gas entrapment between the reaction layers. Under these conditions the reaction of Si_3N_4 with copper is highly improbable.

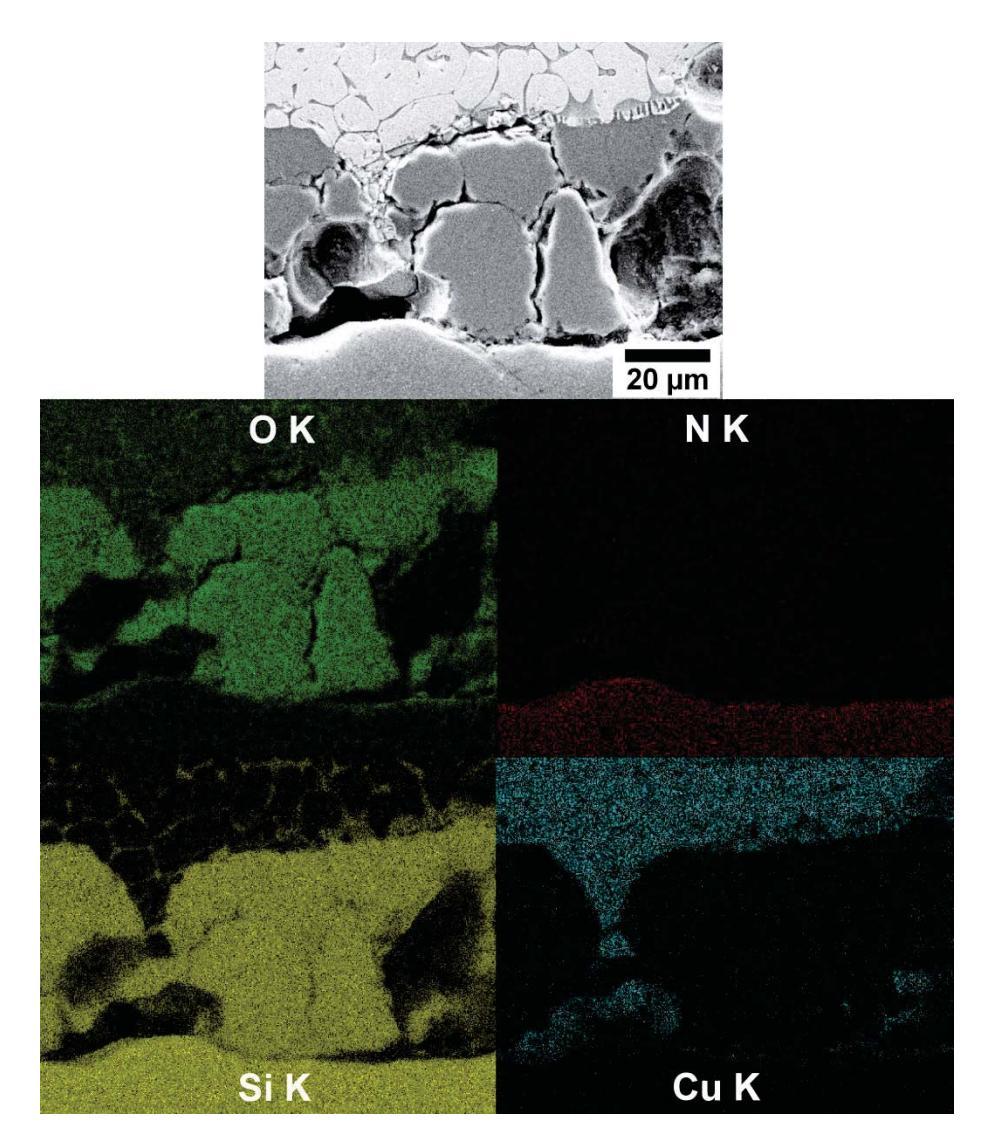
Figure 13. EDX mapping at the near-surface zone of a specimen; three zones are identified: (i) lower – consists mainly of pure silicon nitride; (ii) middle – Si-rich oxide phase, (iii) upper – bright regions: Cu-rich oxides, dark regions: Si-rich oxides

Through EDX mapping it was possible to identify four distinct regions in terms of chemical composition. As shown in the SEM image (Fig. 13), the bottom region was identified as silicon nitride, showing peaks of Si, N, O, Al and Y (first region from the left shown in Fig. 12). The phase in the middle shows high concentrations of Si and O indicating a silicon-rich oxide phase (second region from the left in Fig. 12); peaks of Al and Cu were also identified in lesser quantities (51.2 wt.% Si, 46.0 wt.% O, 1.8 wt.% Cu and 1.0 wt.% Al). The upper region showed two distinct phases: a bright phase which appeared as isolated islands or patches, showing Cu and O signals (91.8 wt.% Cu and 8.9 wt.% O), and a darker phase (silica) surrounding the islands. Under higher magnifications a mixed phase with high content of Cu, O and Si (33.7 wt.% Cu, 32.4 wt.% O, 17.4 wt.% Si, 5.6 wt.% Al and 4.6 wt.% Y) was also identified. A detailed SEM image is shown in Fig. 14.

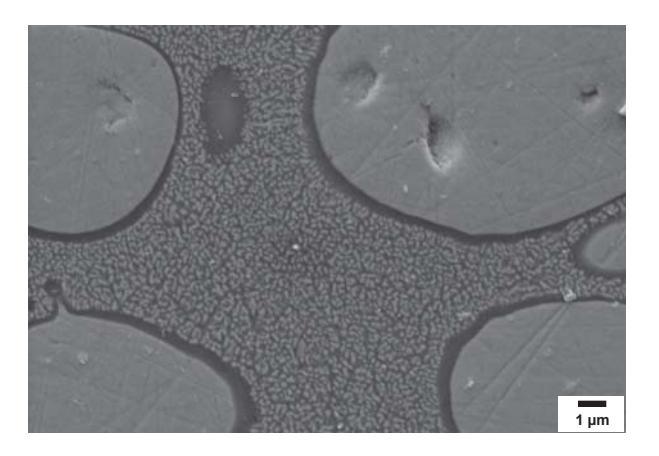
Figure 14. Isolated islands of a copper oxide phase surrounded by a thin layer of silicon oxide phase and a mixture of both phases

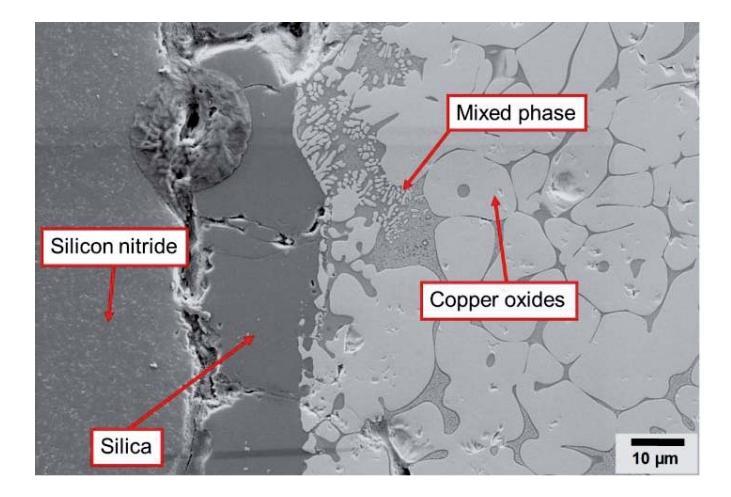
Figure 15. SEM showing the development of oxidation and corrosion zones. The mixed region is shown in Fig. 14 in higher magnification; notice the formation of gas bubbles at the Si_3N_4/SiO_2 interface

A summary of the identified phases is shown in Fig. 15.

When brought into contact with CuO (Fig. 15 and 16), the oxidation temperature of Si_3N_4 is lowered by around 100 °C [7]. The transformation of the oxide layer (SiO₂) covering the surface of silicon nitride from α -quartz to α -cristobalite above 1100 °C also accelerates the aforementioned oxidation process [7]. The thermal dissociation of silicon nitride occurs by the reaction of silicon with free oxygen atoms, which substitute the silicon nitride with silicon oxide. This reaction between silicon nitride and oxygen occurs at temperatures above 950 °C [27] as follows:

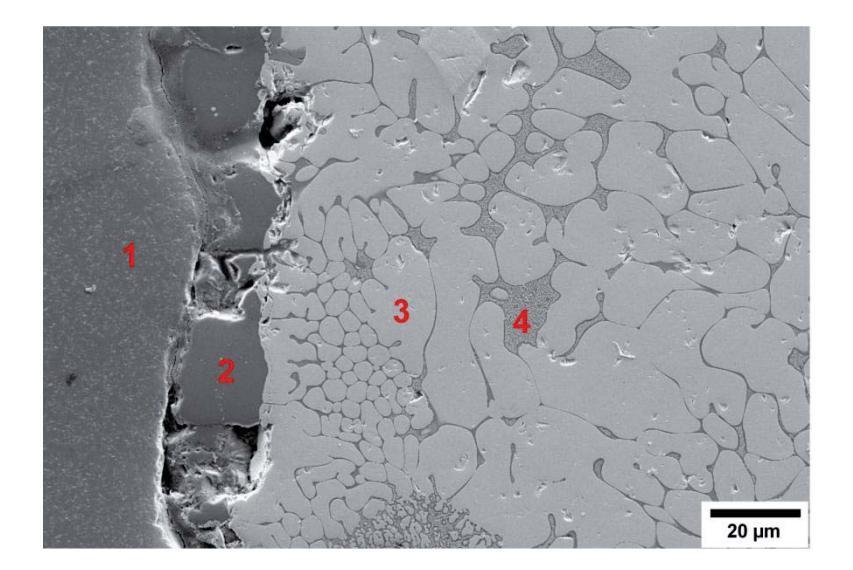
Figure 16. SEM image showing the near-surface zones; the numbers indicate the Raman spectra shown in Fig. 17. The region marked with number "4" is shown in Fig. 14 in higher magnification

A subsequent Raman spectroscopy confirmed these results. Fig. 16 shows an SEM image of the various phases labelled 1-4; wherein the region marked by number four is shown in higher magnification in Fig. 14.

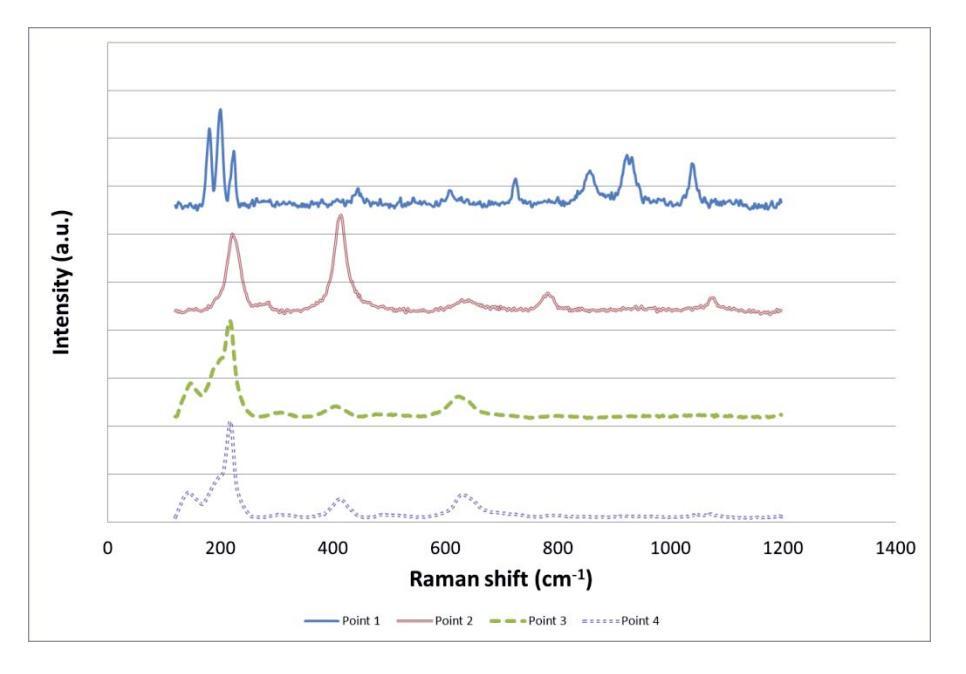
Figure 17. Raman spectra corresponding to the zones specified in Fig. 16

The Raman spectra shown in Fig. 17 and summarised in Table 4 correspond to the zones specified in Fig. 16.

It should be noted that Raman spectroscopy is not able to detect pure metallic phases such as Cu.

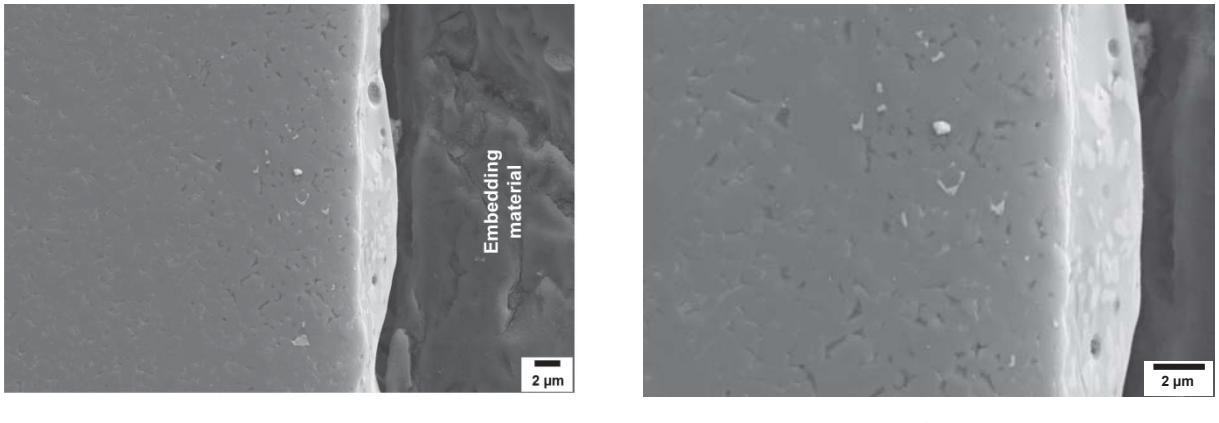
Figure 18. (a) Near-surface zone of a specimen submerged in molten copper at 1200 $^{\circ}$ C in Ar and N₂ atmosphere for 100 cycles each lasted 60 s; (b) detailed view showing the oxide layer and different phases

After being submerged in the melt under inert gas atmosphere, the specimens showed no signs of corrosion or wetting with copper. The near surface zones of the specimens showed signs of oxidation (Fig. 18a) and higher content of sintering additives were detected on the surface. The oxide layer here also appeared to be composed of different phases (Fig. 18b). No signs of fracture were detected on the surfaces of the specimens.
